“सिक्टा सिचाई आयोजना: समस्या र समाधान”

सिक्टा सिंचाइ आयोजना: समस्या र समाधान

कृष्ण प्रसाद नेपाल

आयोजना निर्देशक

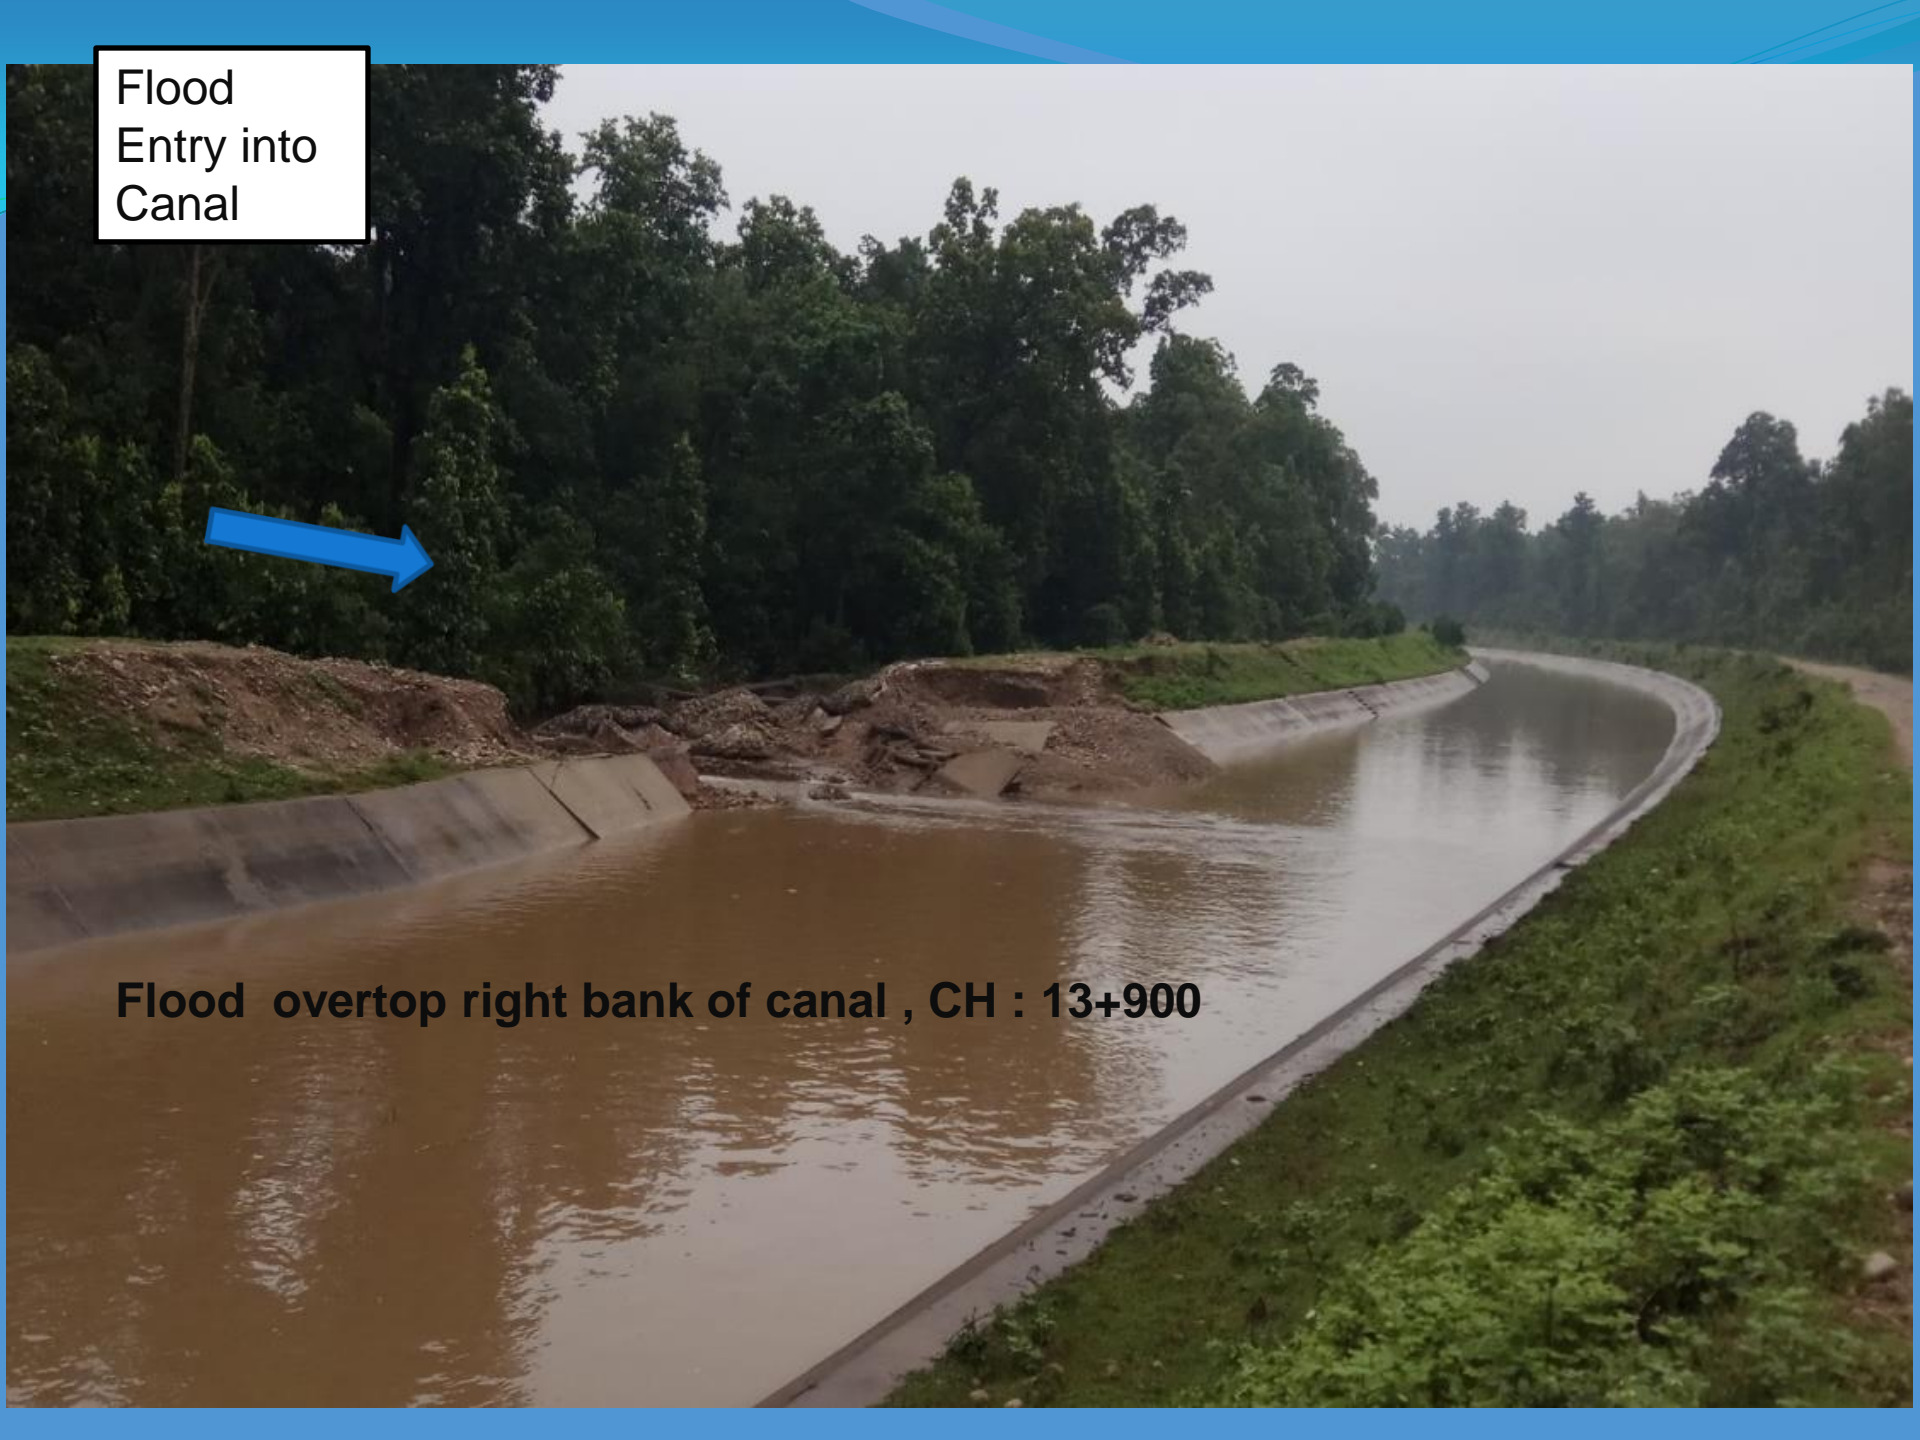
Flood overtop right bank of canal , CH : 13+900

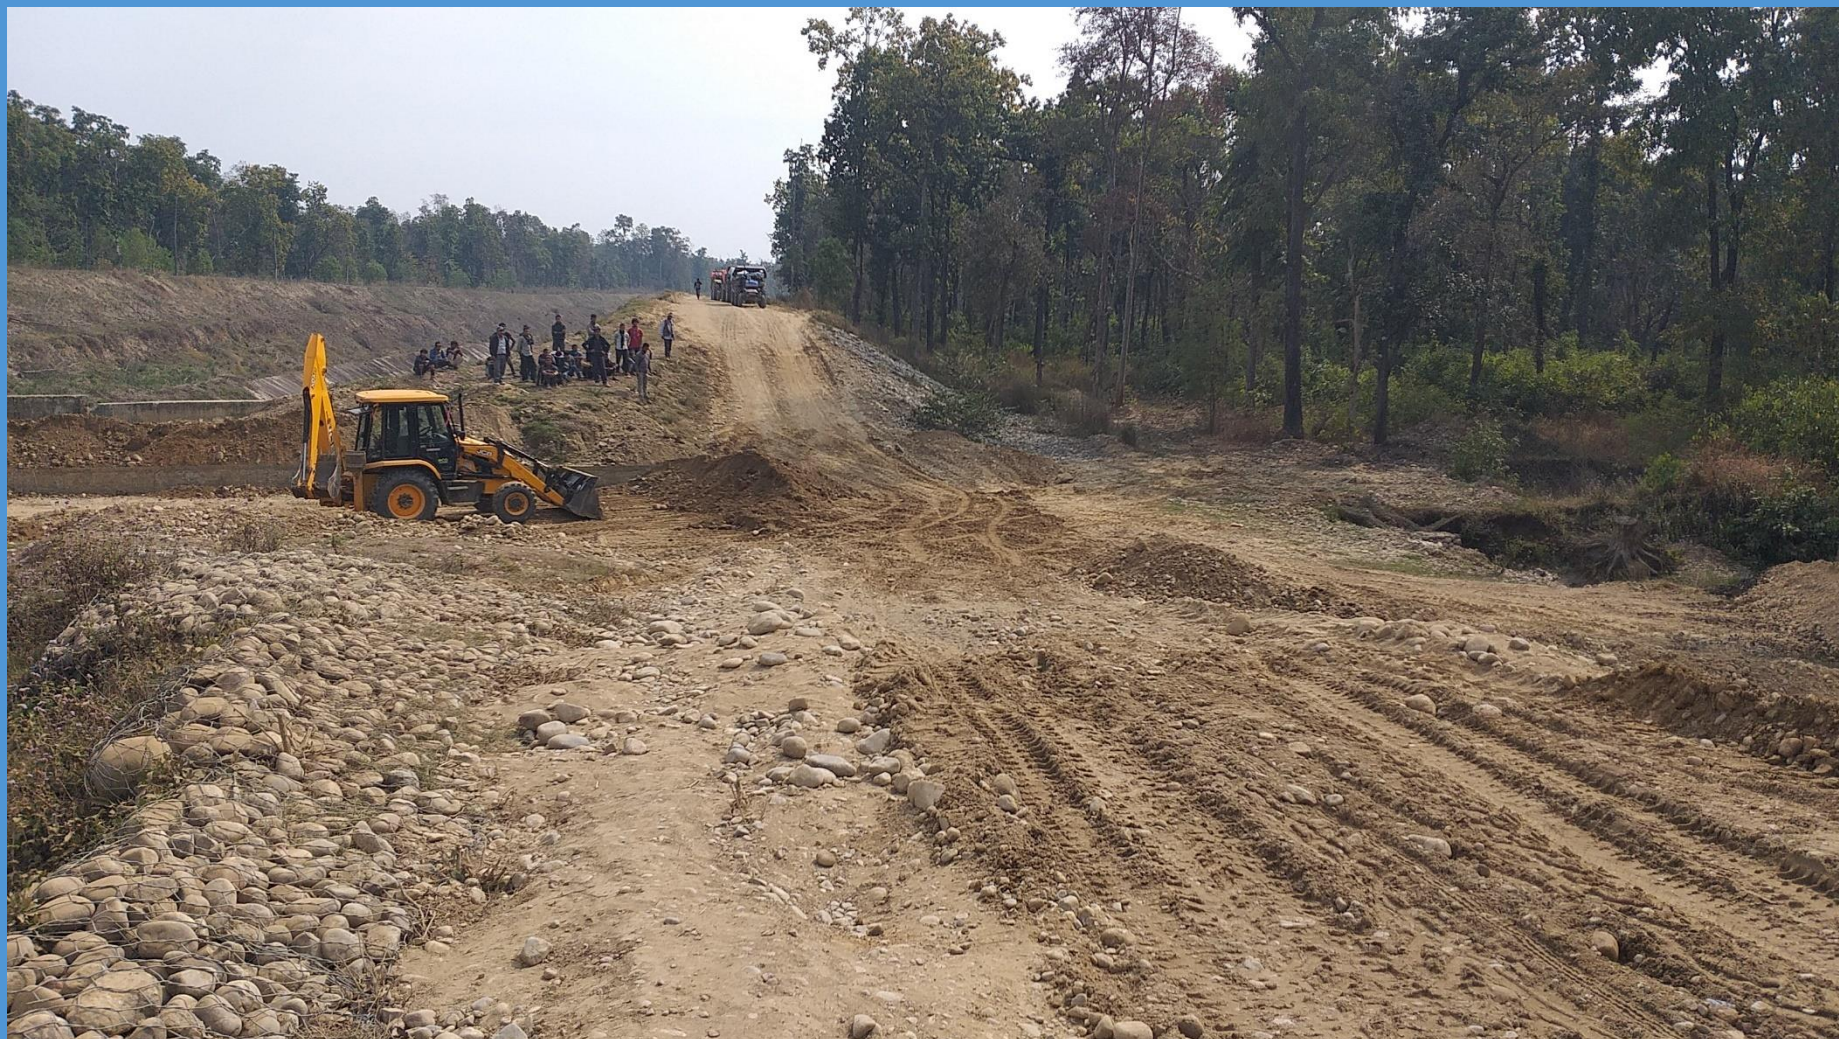
Flood Entry at CH: 18+300

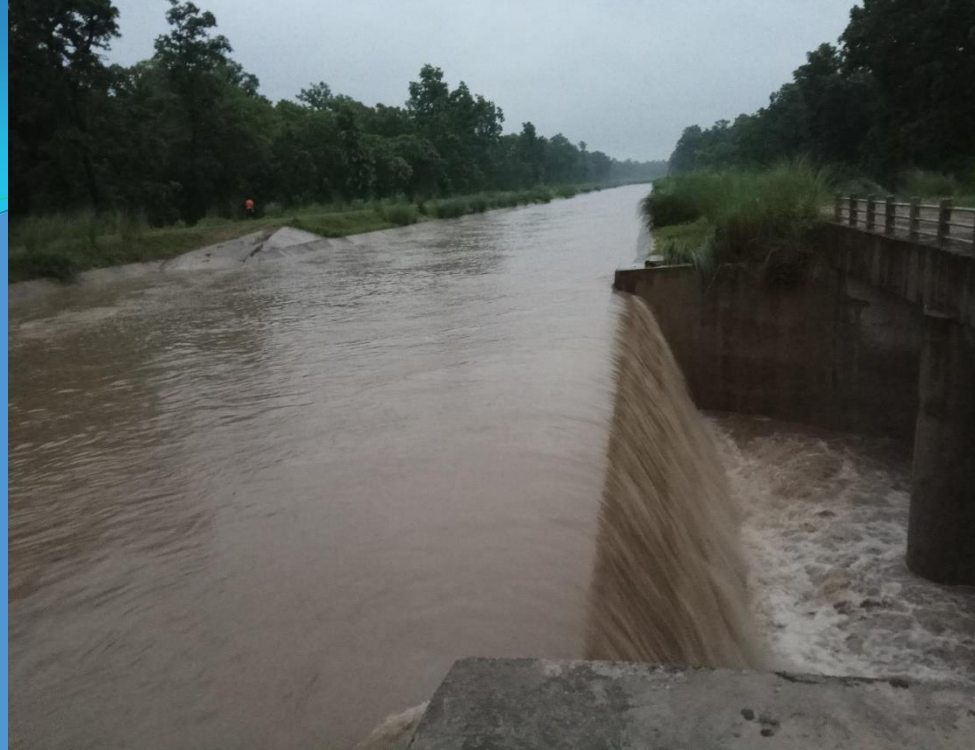
Flooding of Sikta Main Canal, CH : 18+000

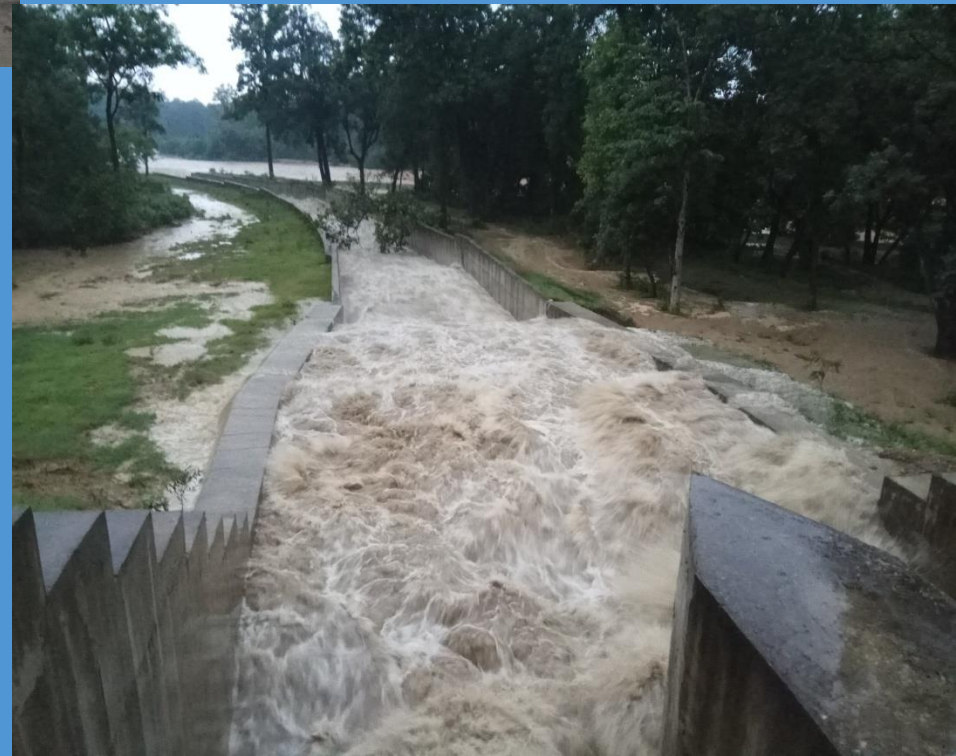
**Canal Water Spill out from
Spillway, CH : 20+000**

**Canal Water Escape out from
Escape,
CH : 20+000**

**2071 & 2074 heavy rainfall > 400
mm/24 hr.**

**Siphon, DUP sufficient to pass flood
water.**

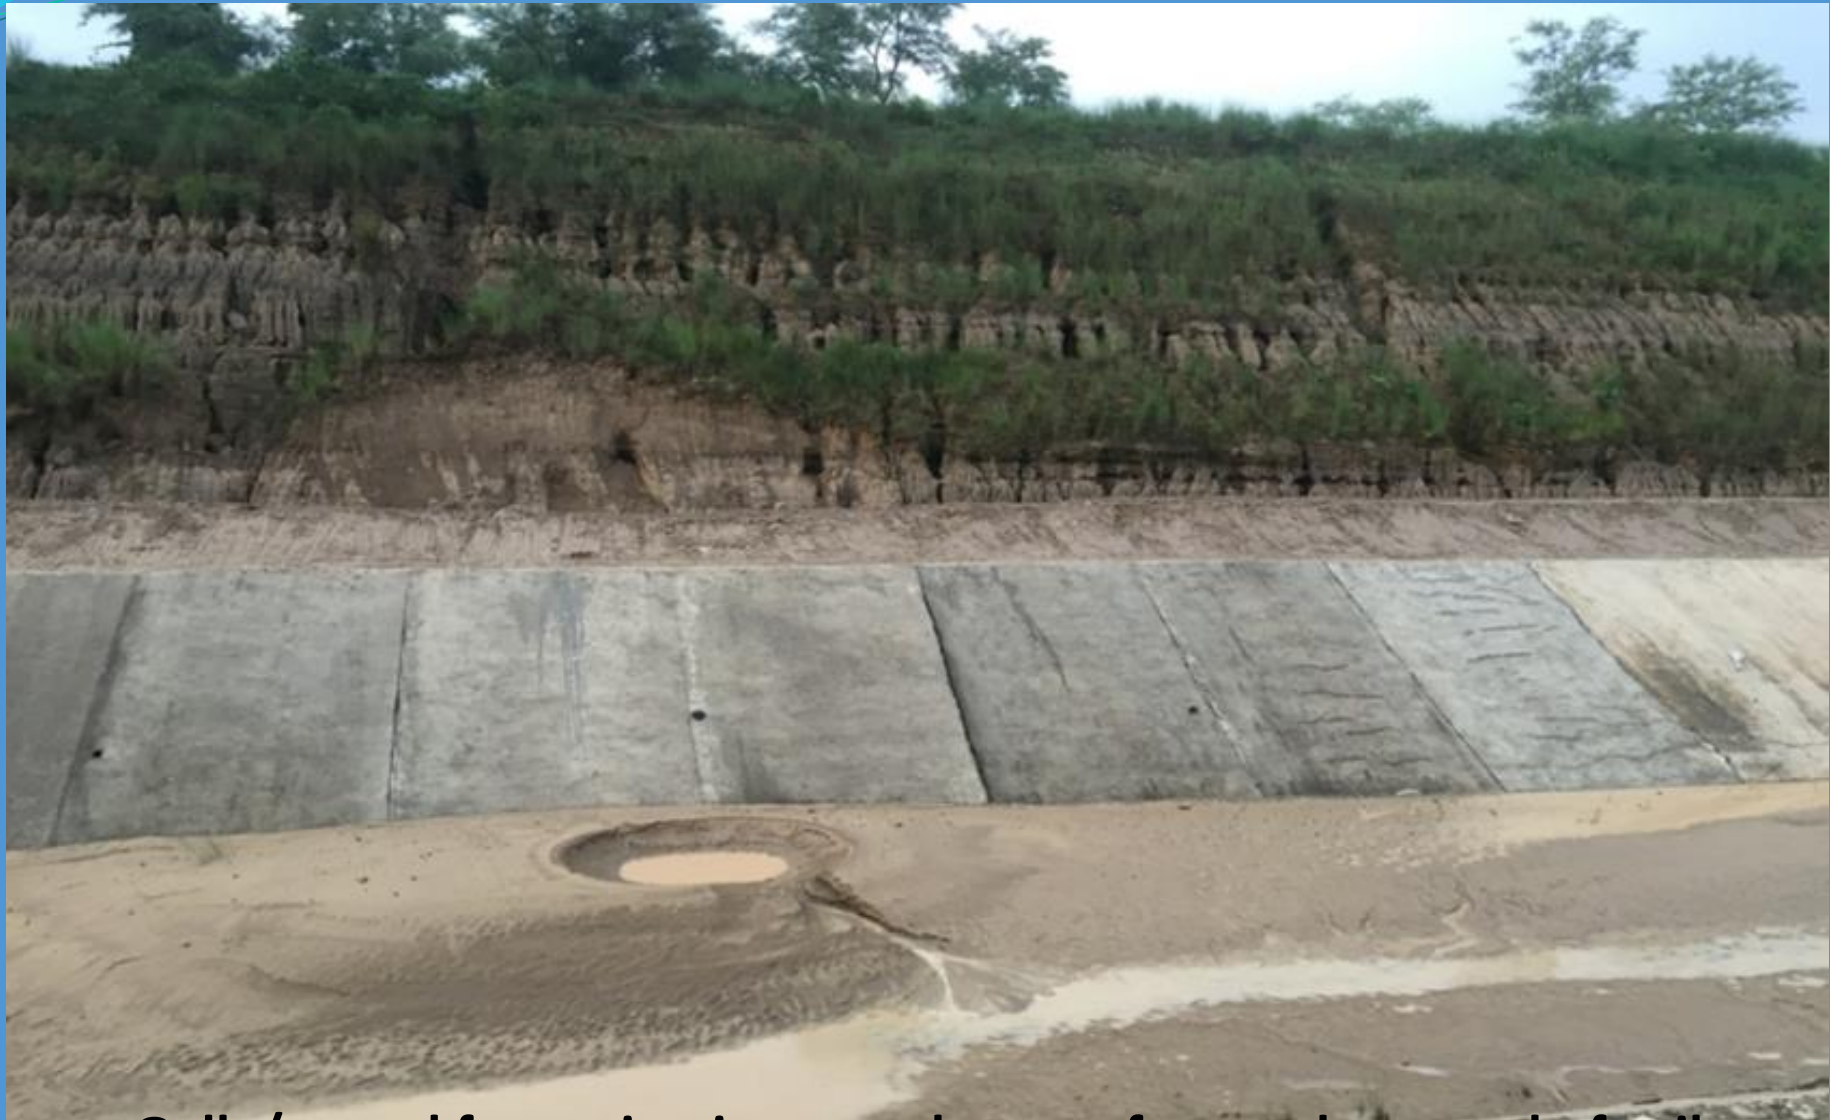
Deep cutting area- Reach 21+175 TO 22+740 (Balapur village area)

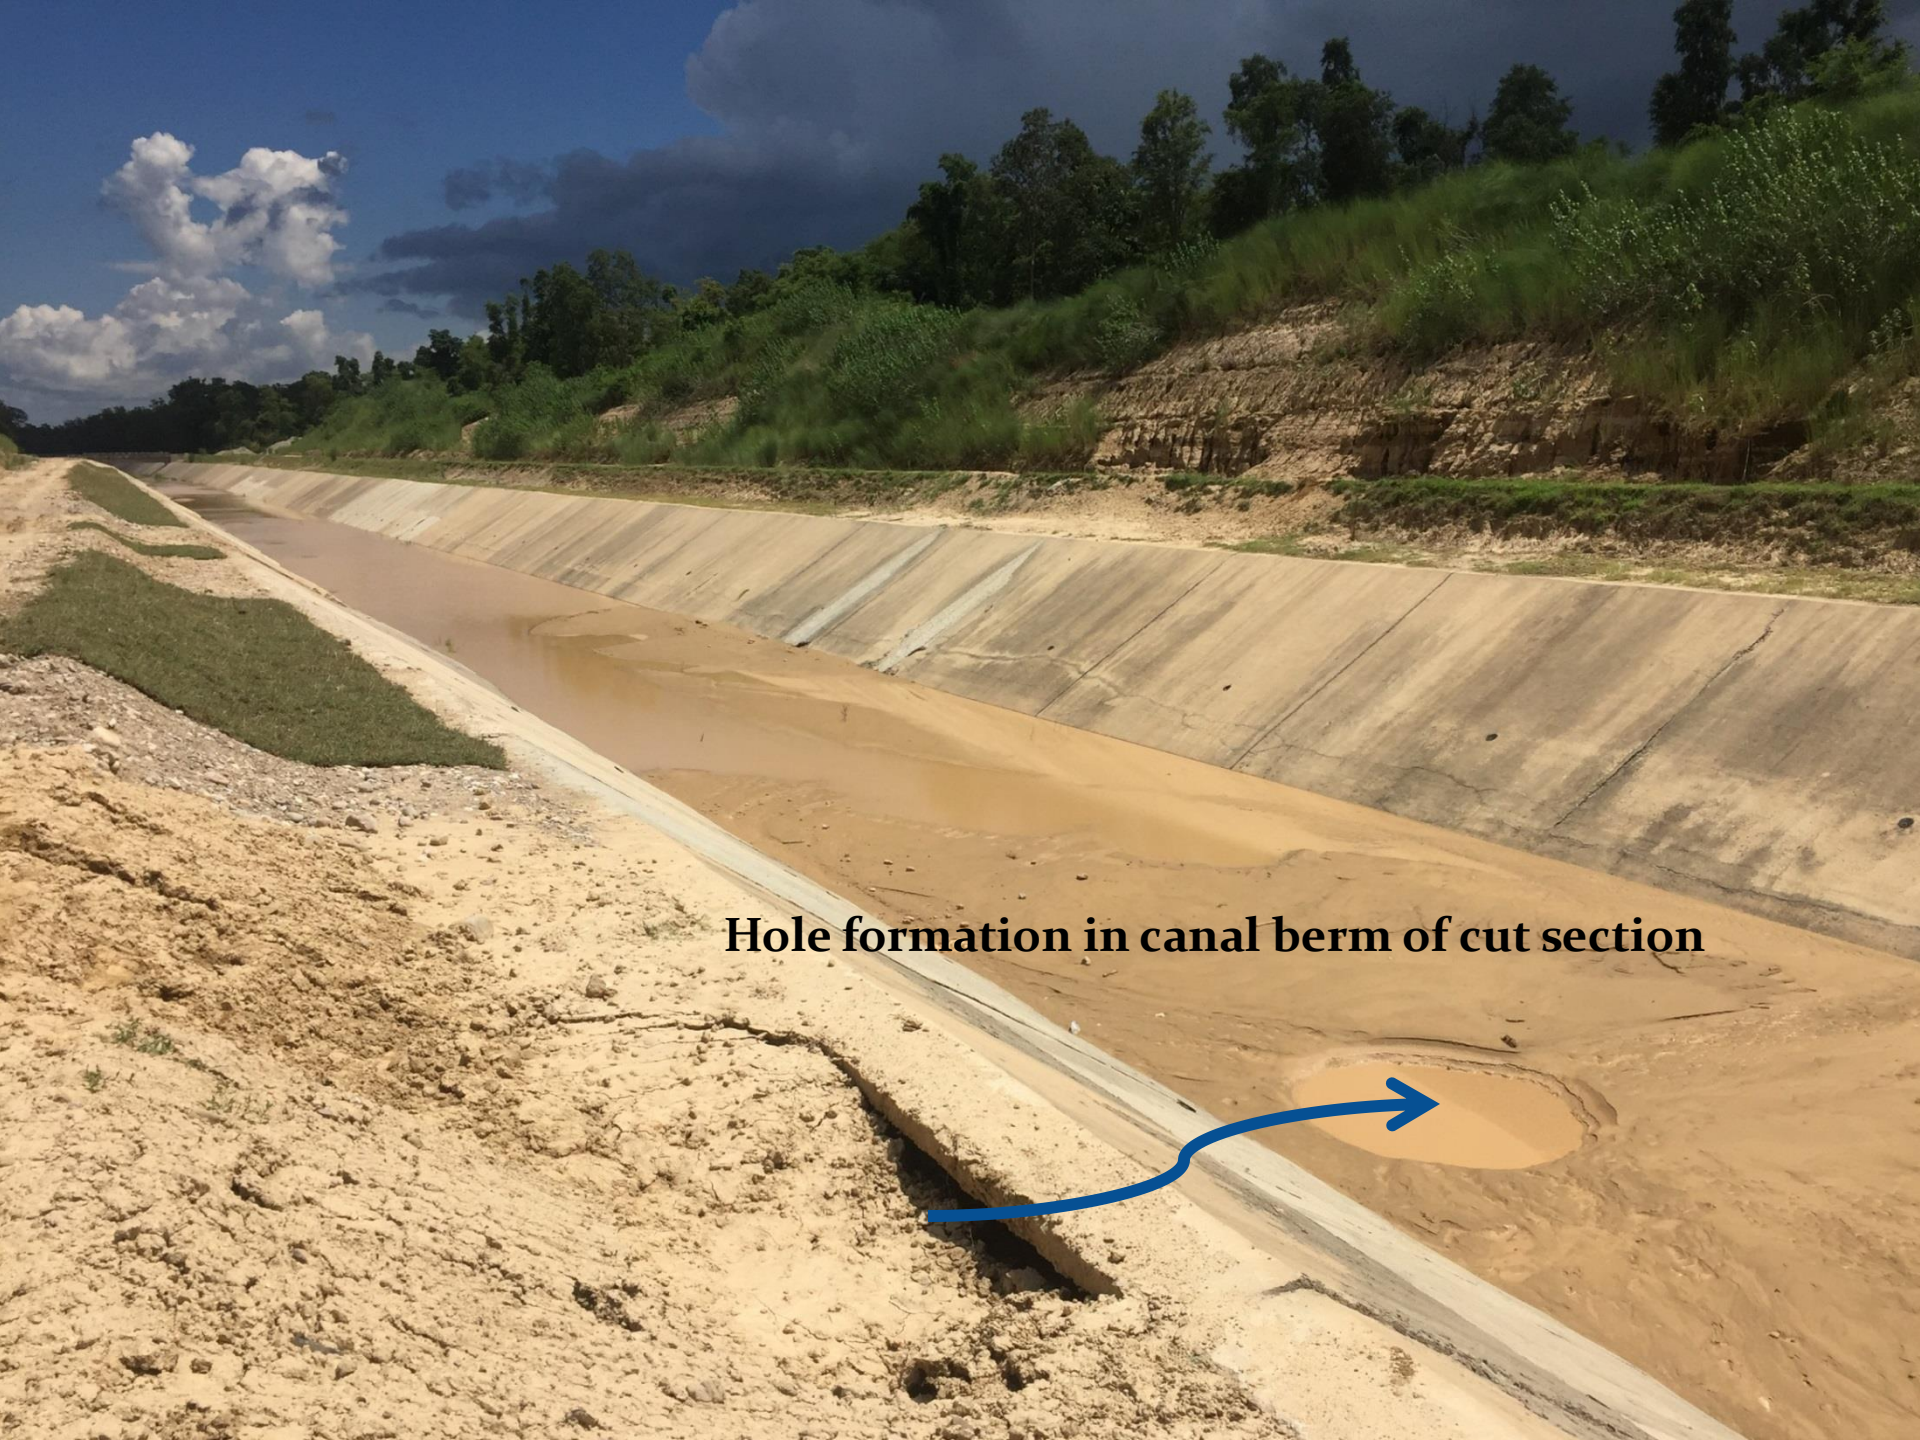
Gully/tunnel formation in natural cut surface and removal of soil

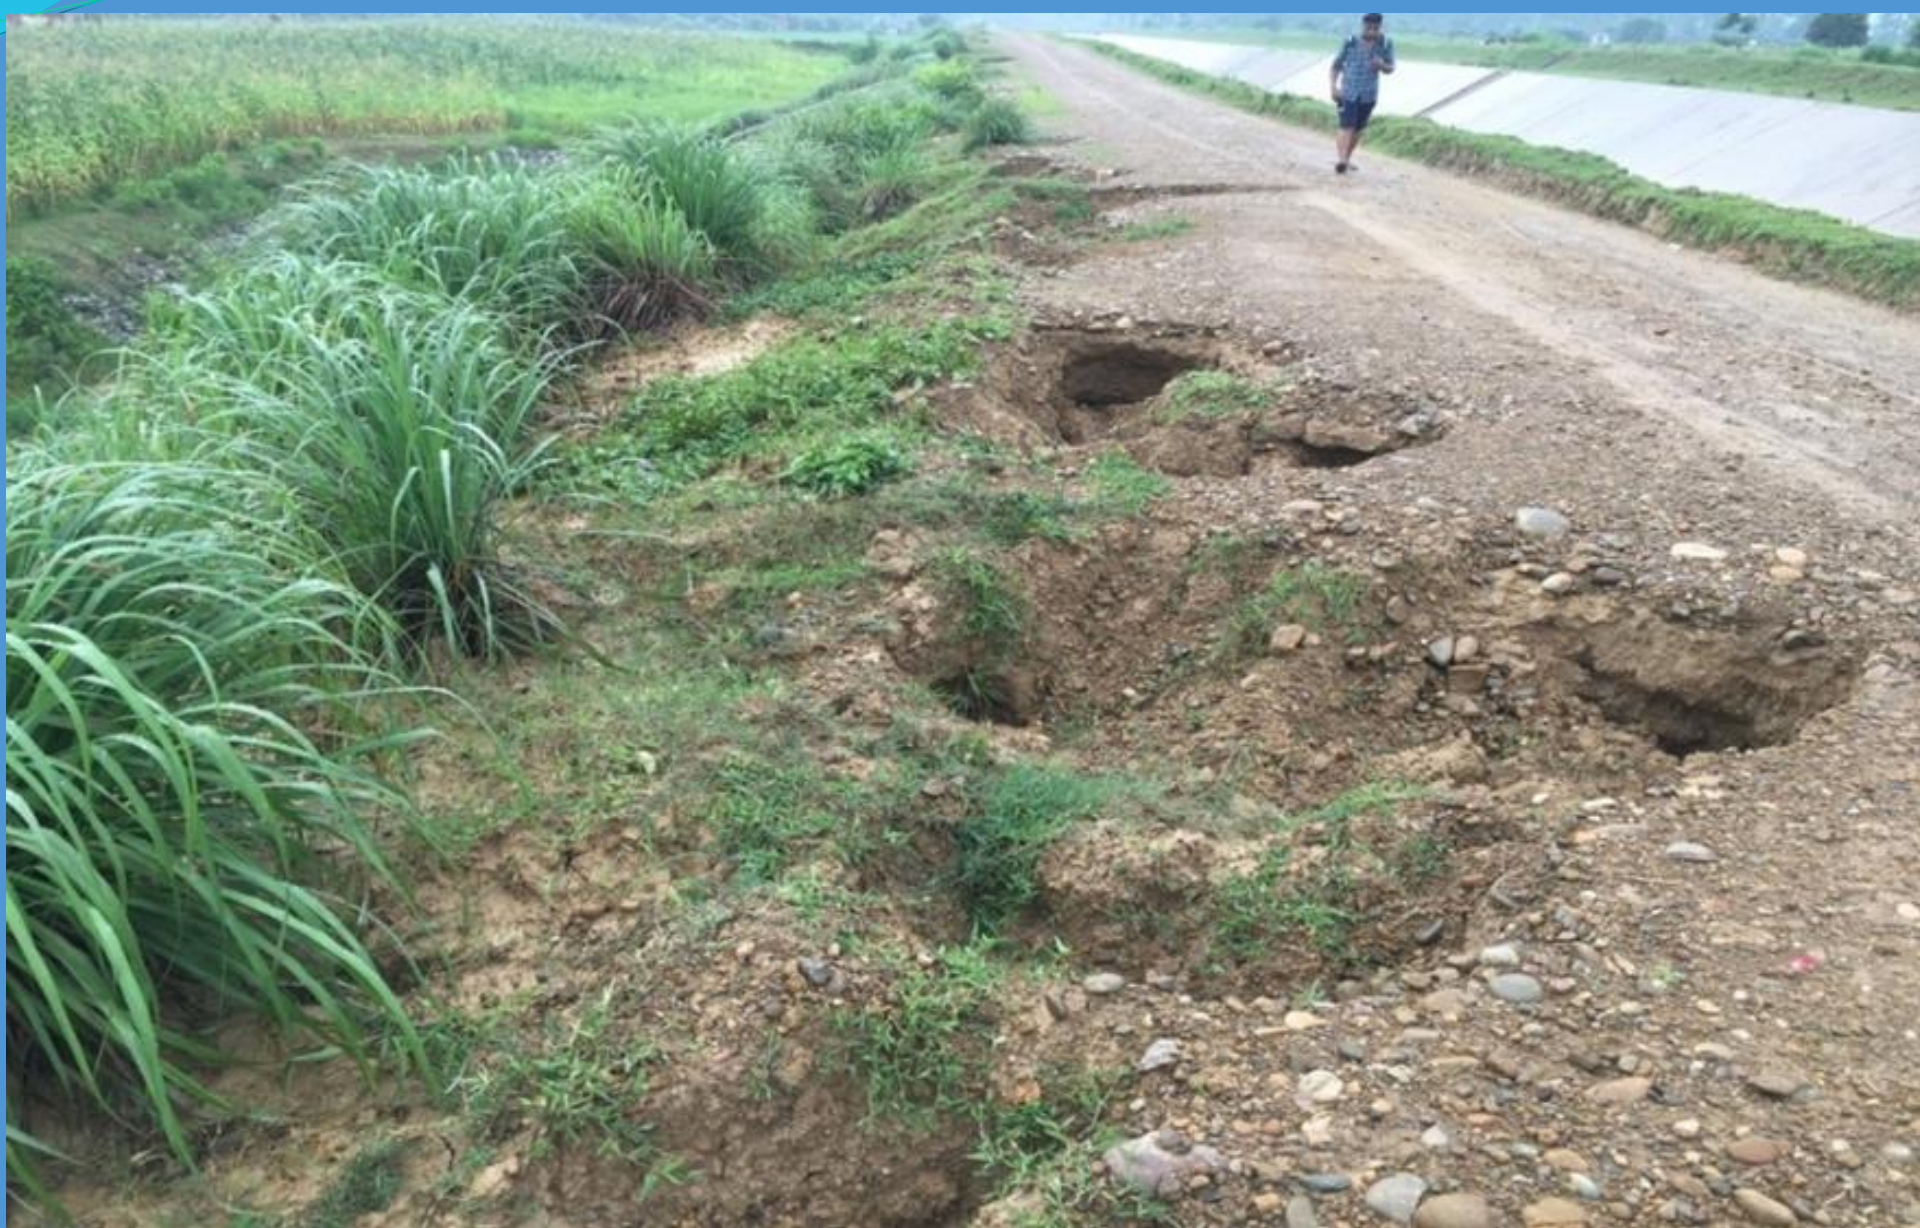
Hole formation in canal berm of cut section

Reach 24+415 TO 24+704 (Dhakeri village area)
visible hole near service road side in fill section

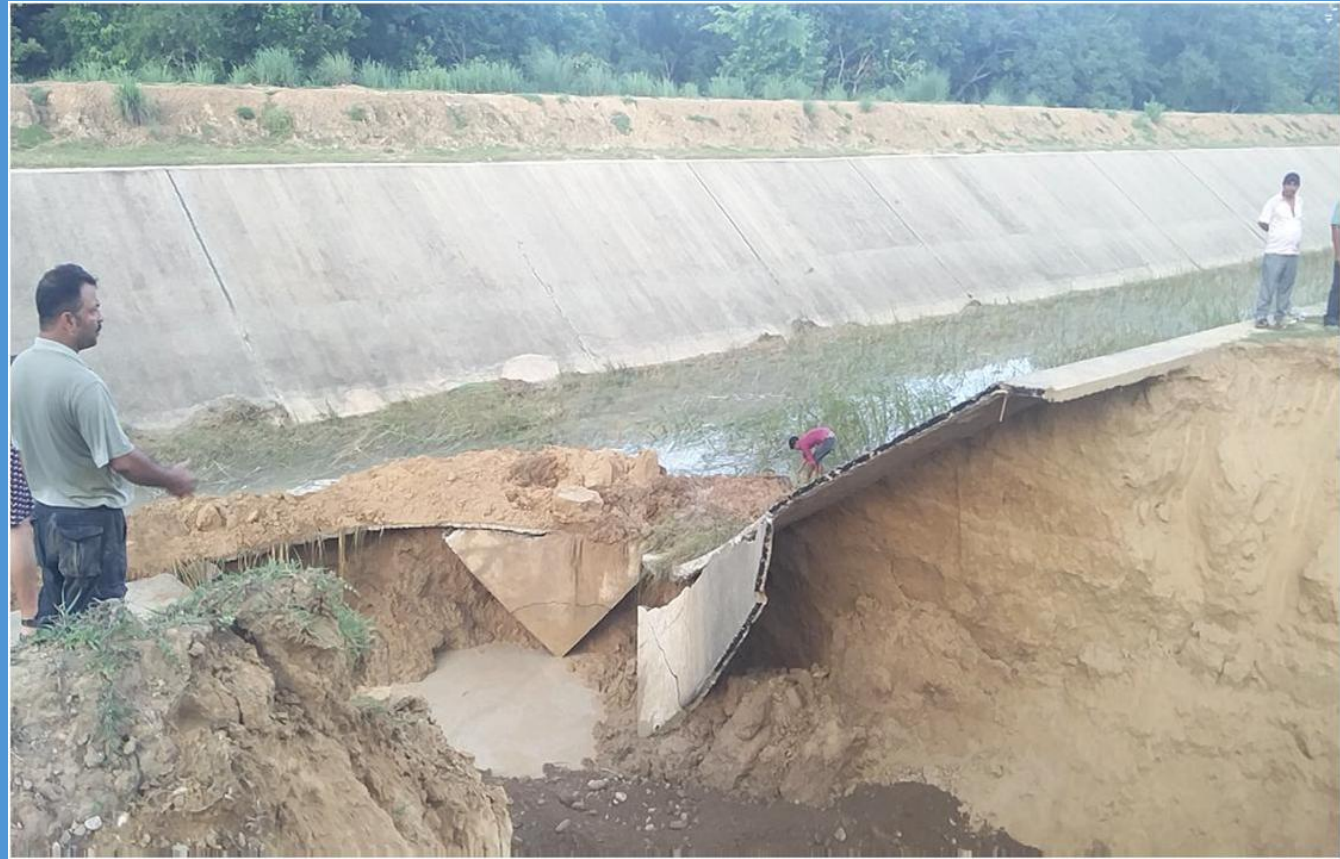
२०७५।४।७ मा पुरेको
(Filling) बनाएको
स्थानमा (२२+८९०)
टुटेको नहर

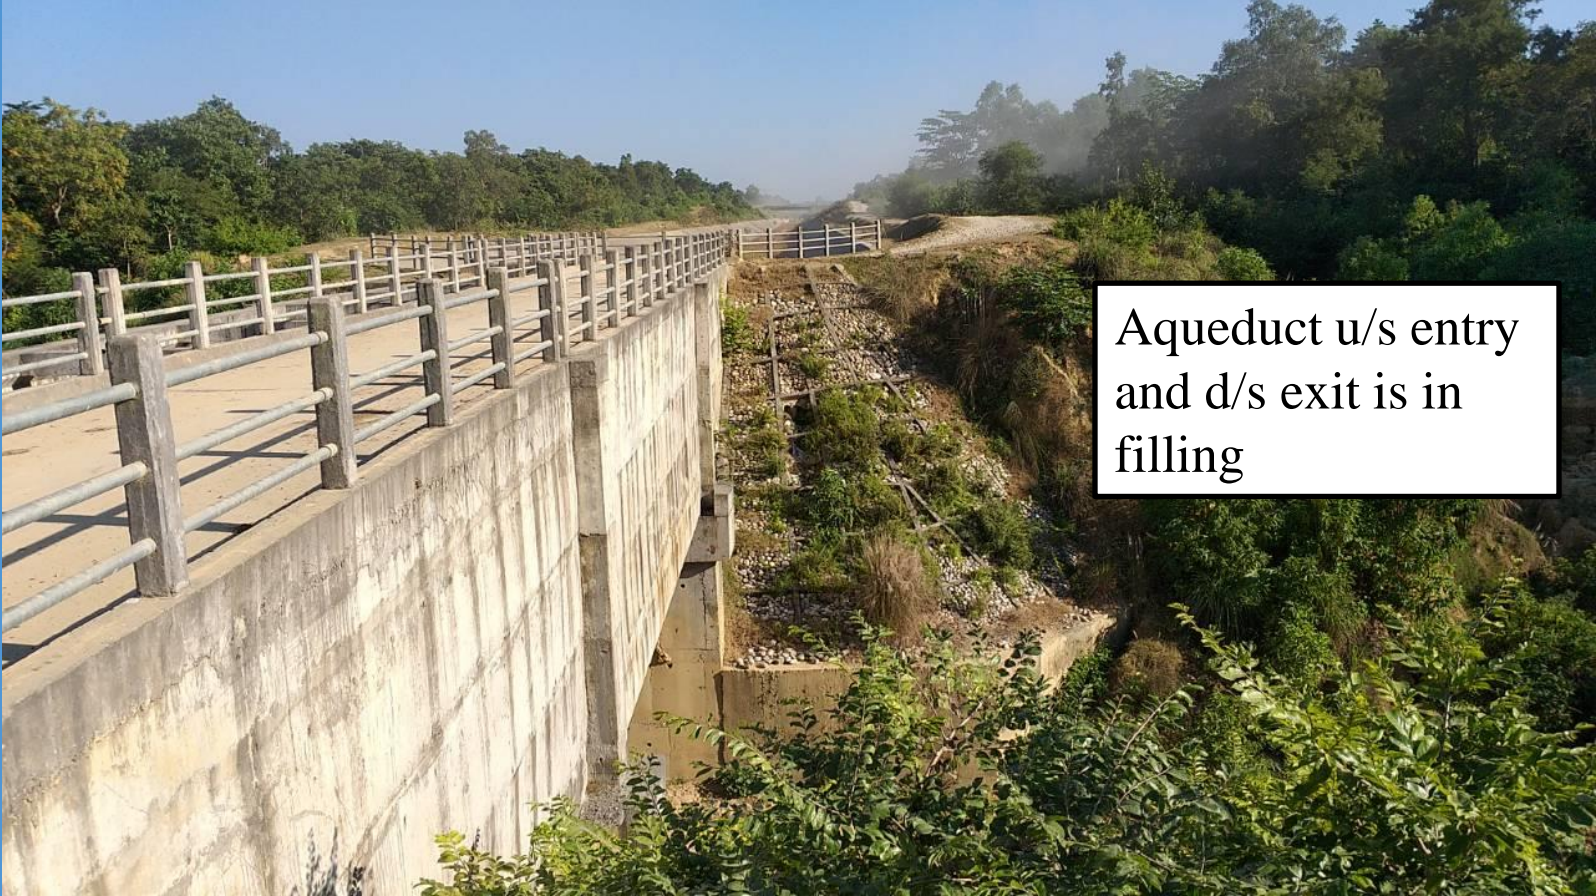
Aqueduct u/s entry
and d/s exit is in
filling

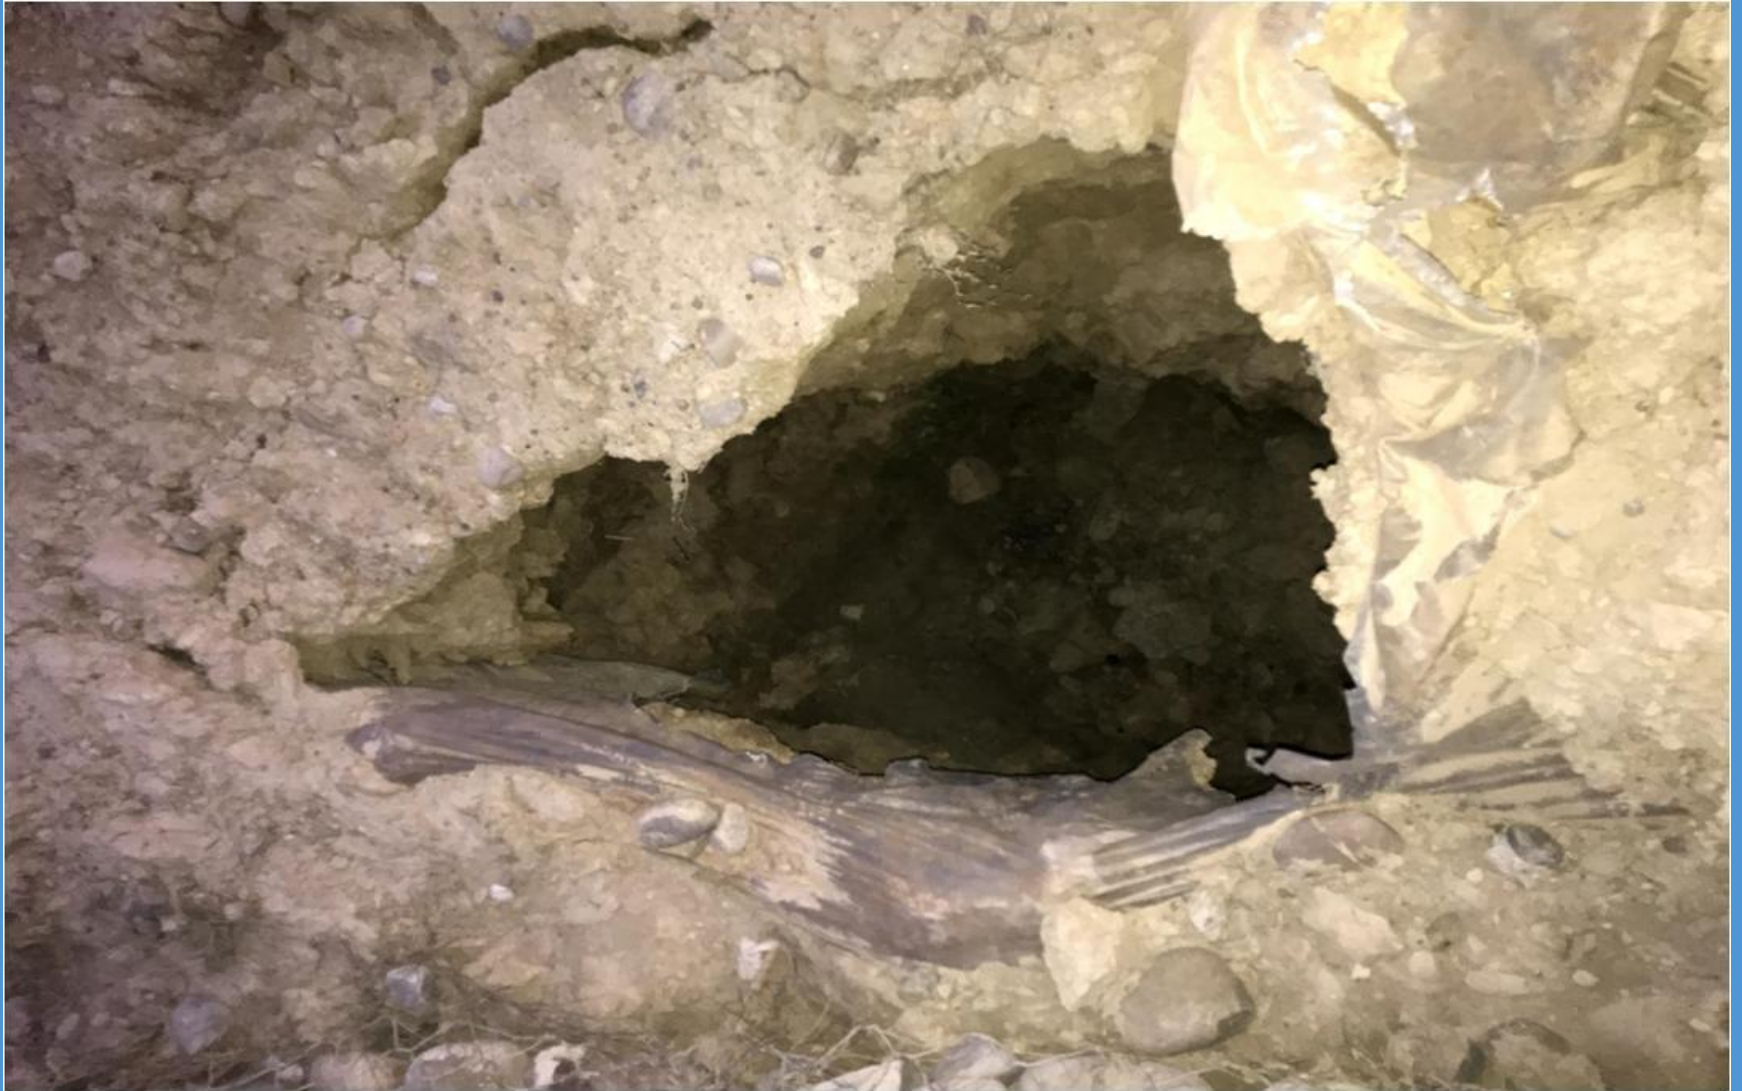
चेनेज २+५००, गबारपुरमा वनक्षेत्र हुँदै खैरी खोलाबाट आएको पानी
नहरमा पसी क्षति गरेको

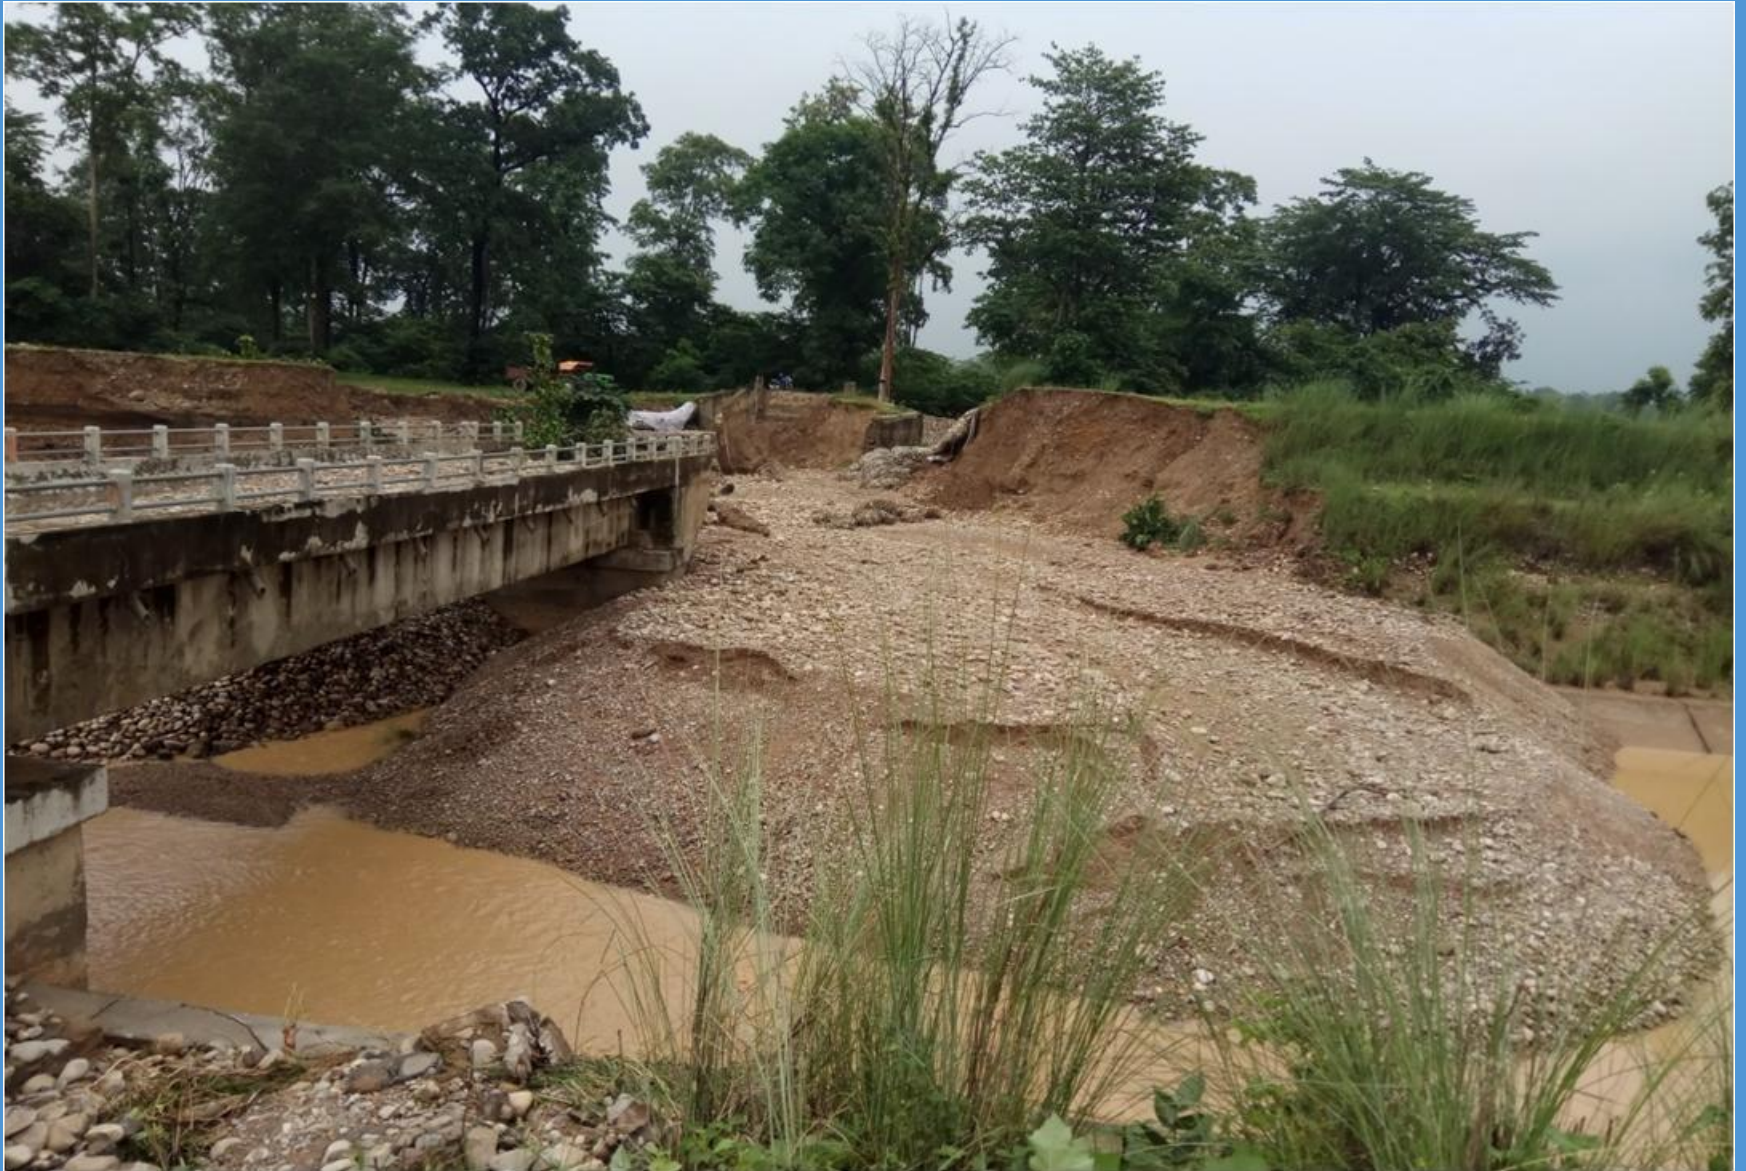
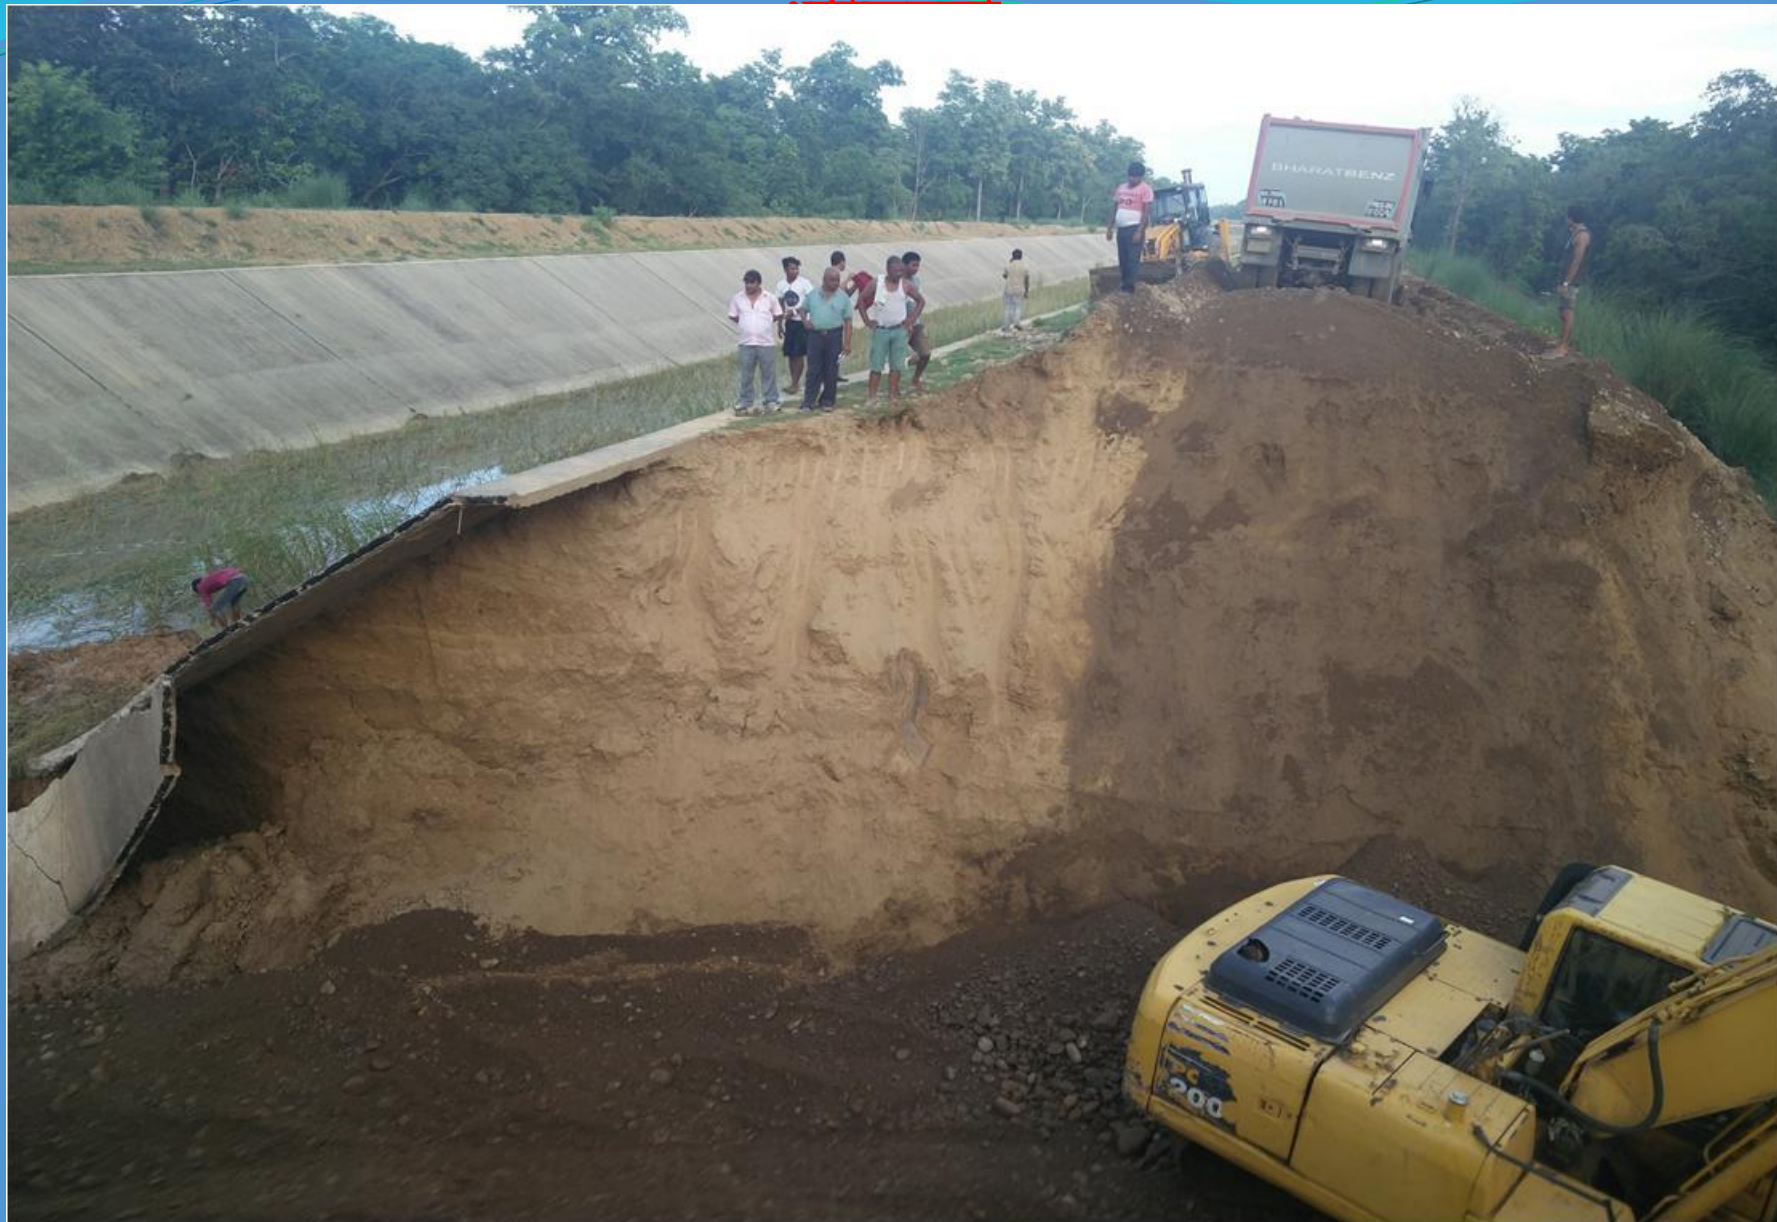
श्रावण ७, २०७५ मा दायाँ मूलनहरको बायाँ डील चेनेज २२+८९० मा

श्रावण ७, २०७५ मा दायाँ मूलनहरको बायाँ डील चेनेज २२+८९० मा भत्किएको
