“सिक्टा सिचाई आयोजना: समस्या र समाधान”

सिक्टा सिंचाइ आयोजना: समस्या र समाधान

कृष्ण प्रसाद नेपाल

आयोजना निर्देशक

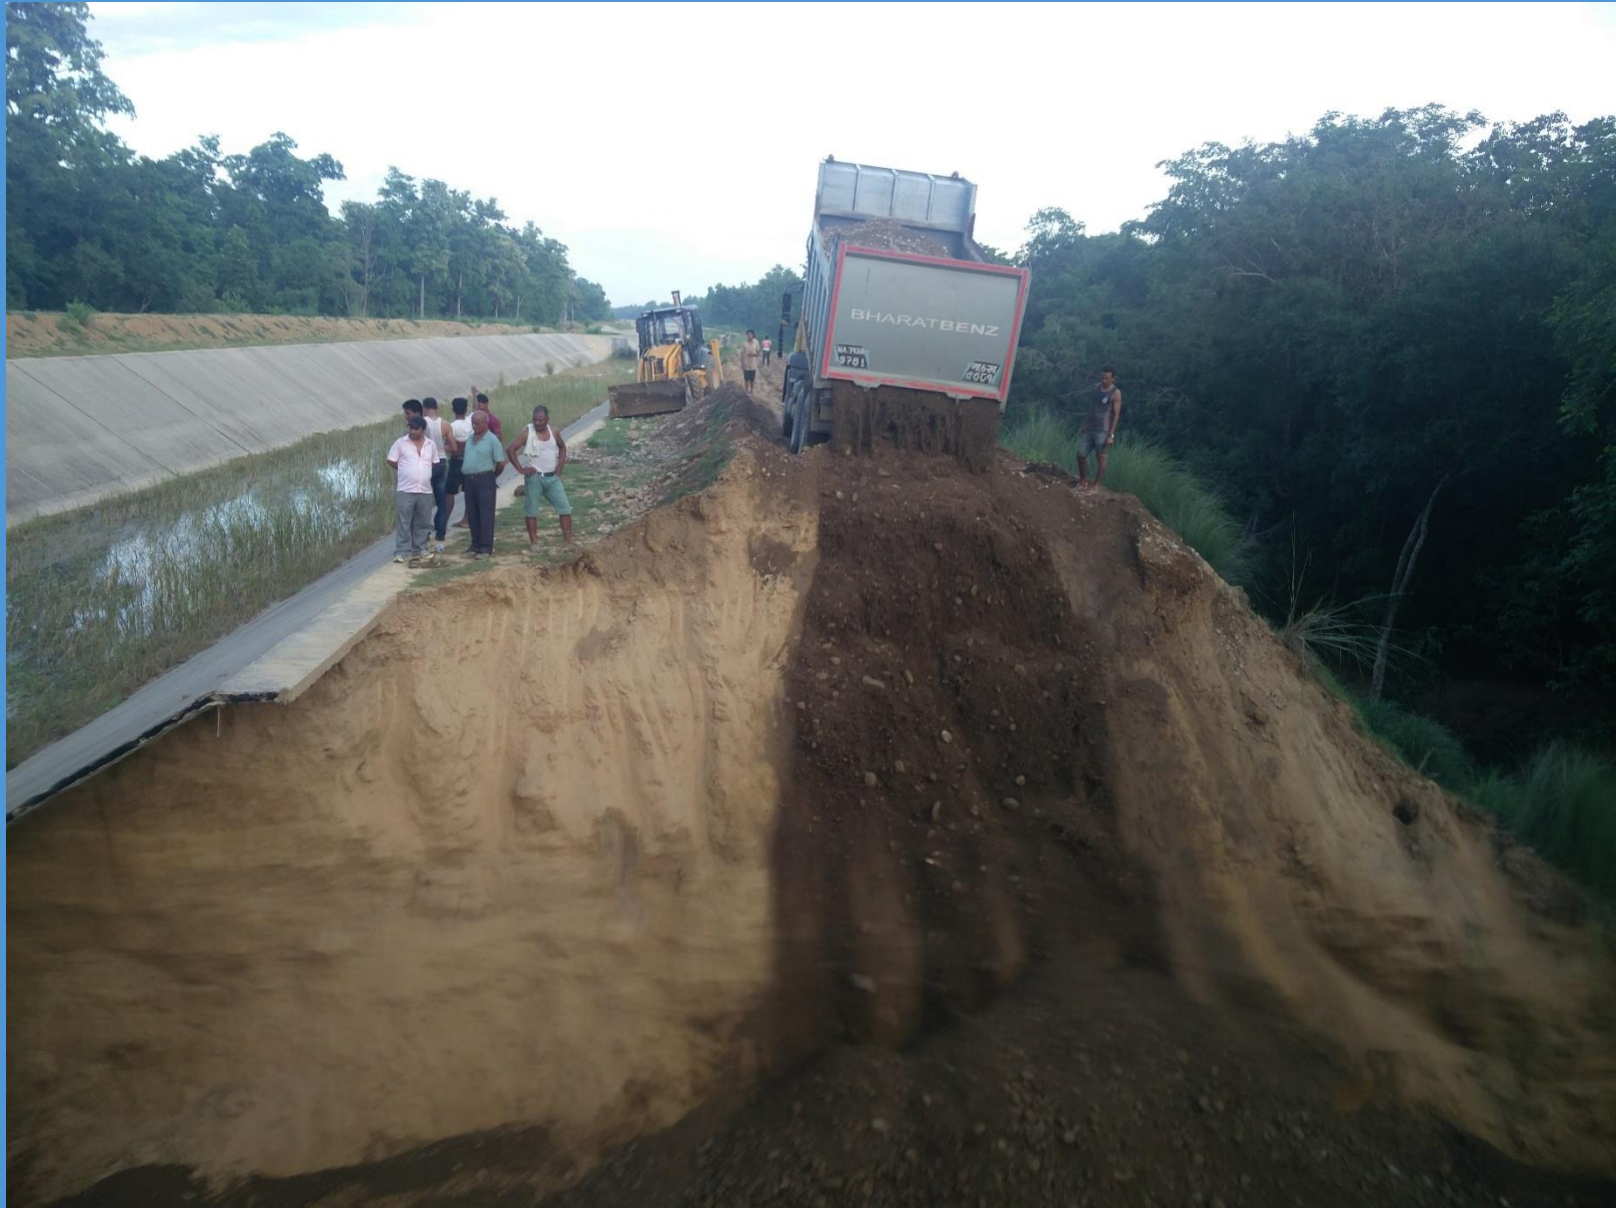
जग्गा विवादका कारण अधुरो नहर
