“सिक्टा सिचाई आयोजना: समस्या र समाधान”

सिक्टा सिंचाइ आयोजना: समस्या र समाधान

कृष्ण प्रसाद नेपाल

आयोजना निर्देशक

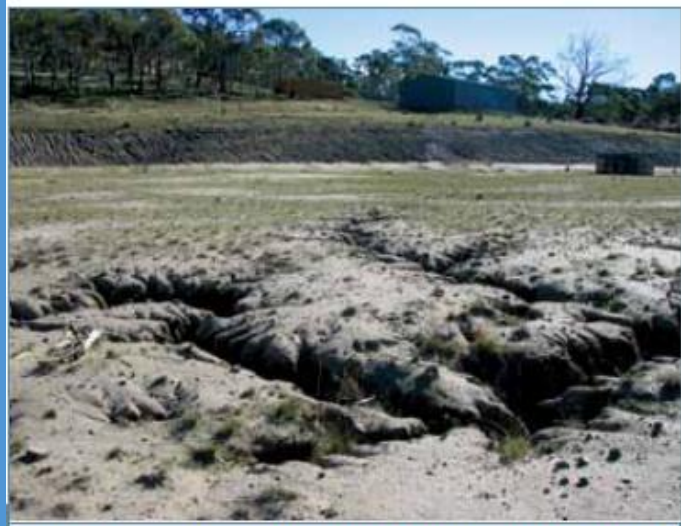
Figure 18. (Same site as Figure 17) Tunnel erosion in footings intended for a large building. Erosion resulted from ponding of rainwater on highly dispersive fill. The fill contains a number of narrow slots (up to 1.2 meters deep) caused by surface water 'dissolving' through the footing.
