“सिक्टा सिचाई आयोजना: समस्या र समाधान”

सिक्टा सिंचाइ आयोजना: समस्या र समाधान

कृष्ण प्रसाद नेपाल

आयोजना निर्देशक

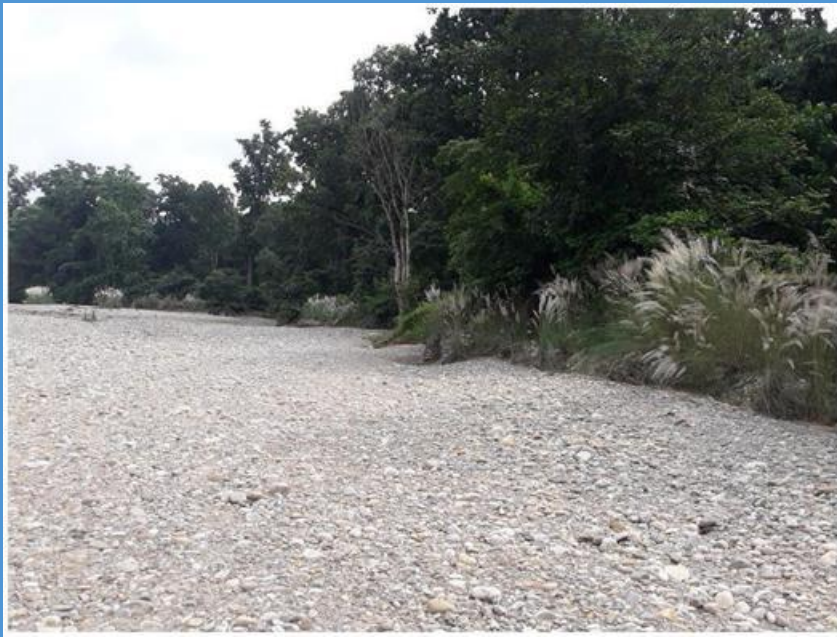
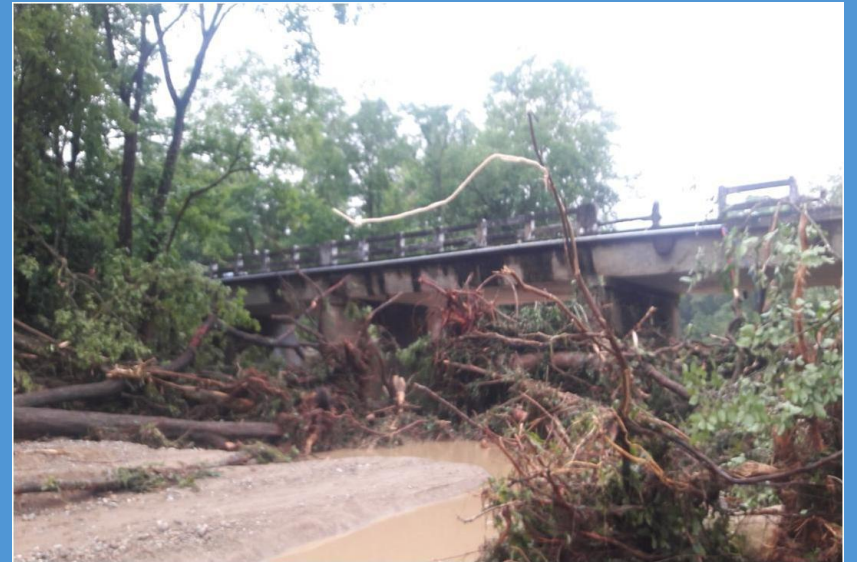
२ निकुन्ज क्षेत्रमा बाढी ब्यवस्थापन

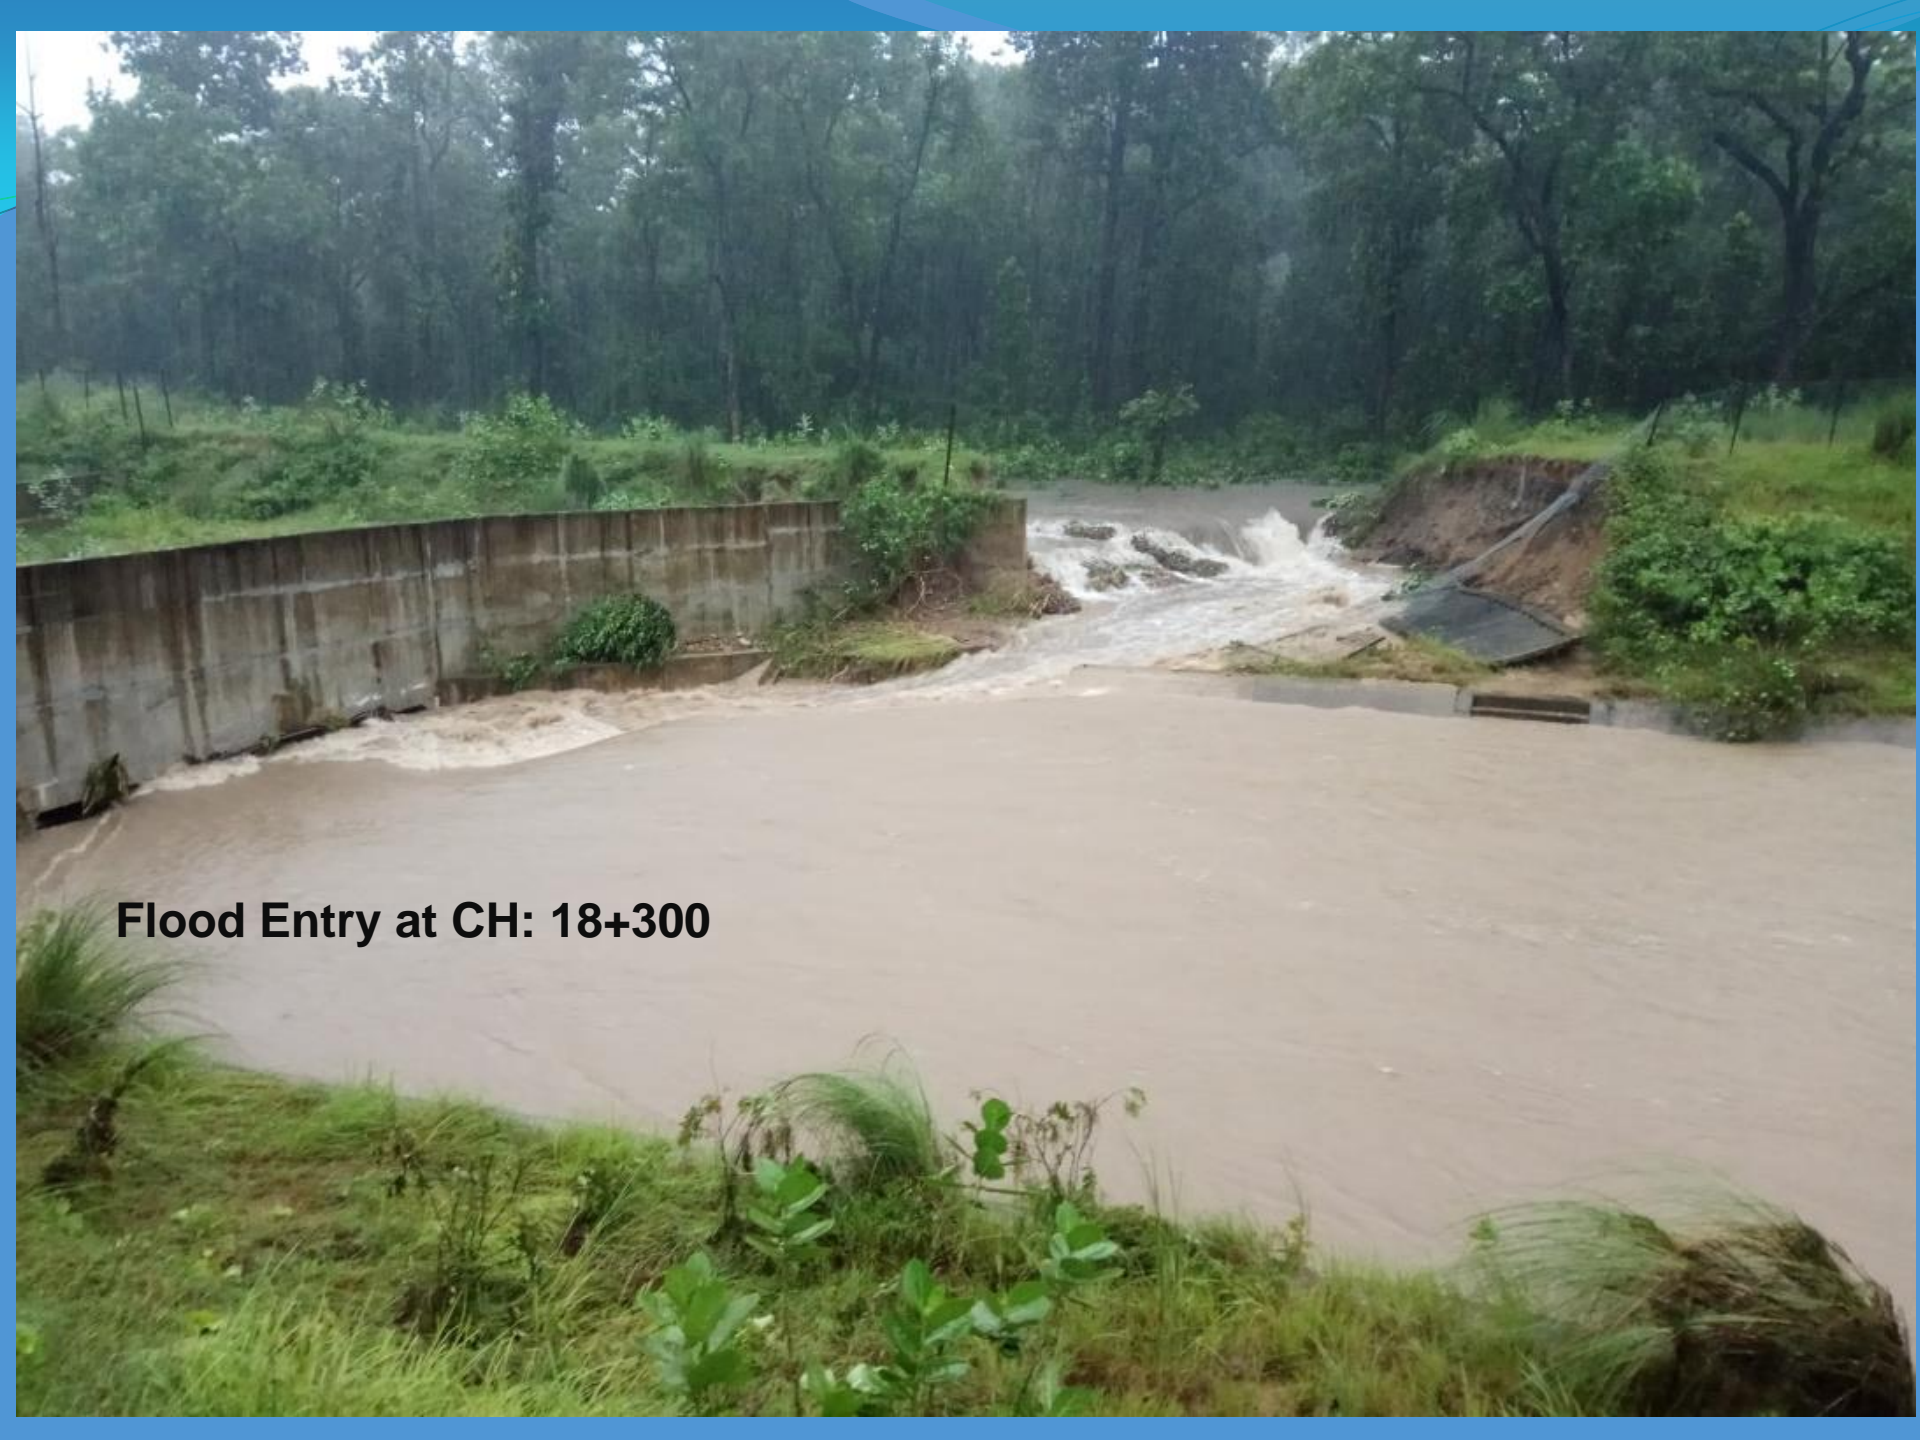
Flood Entry at CH: 18+300

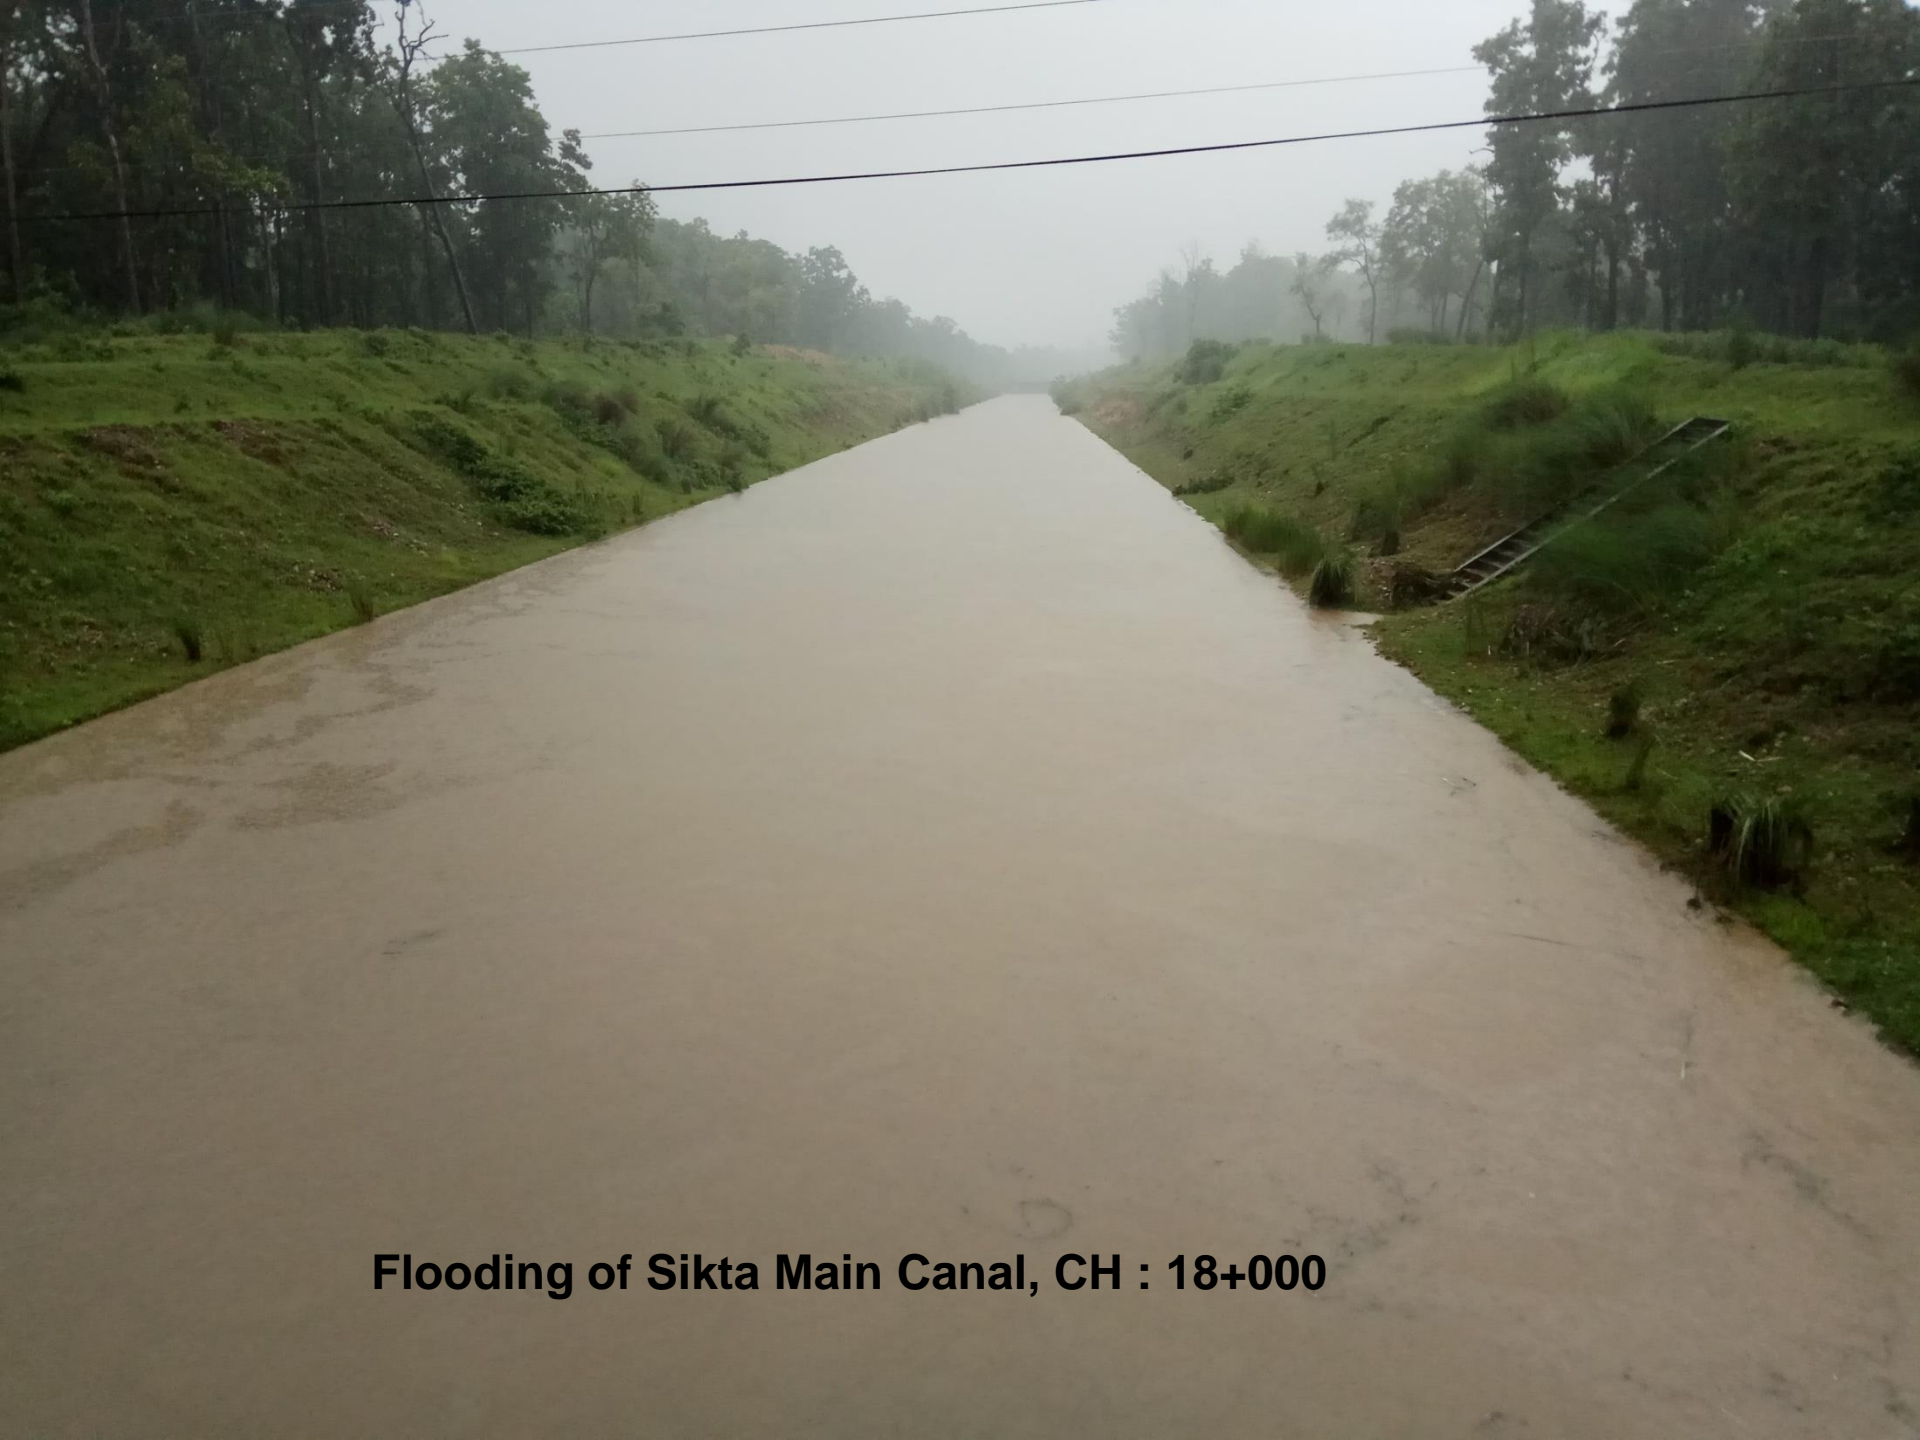
Flooding of Sikta Main Canal, CH : 18+000

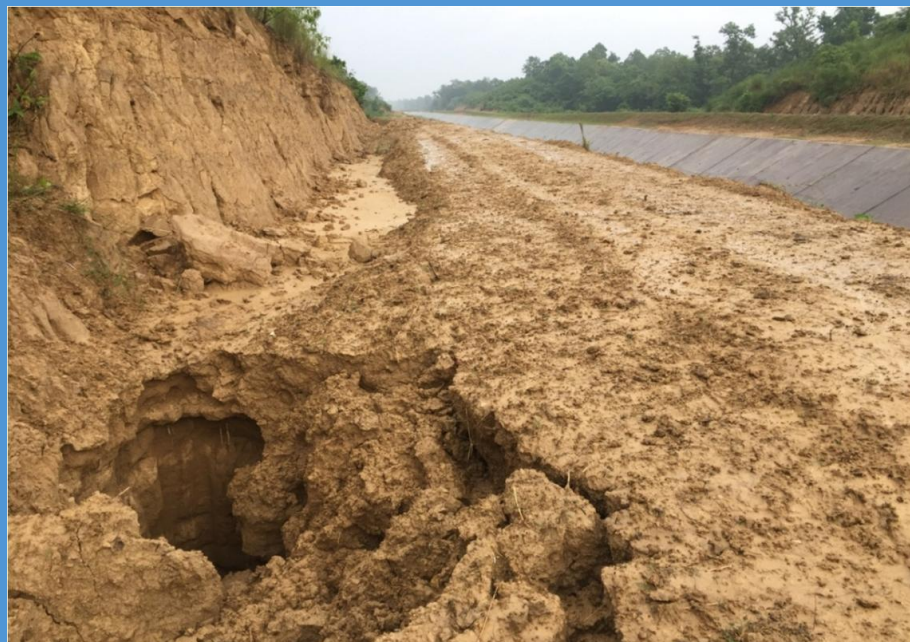
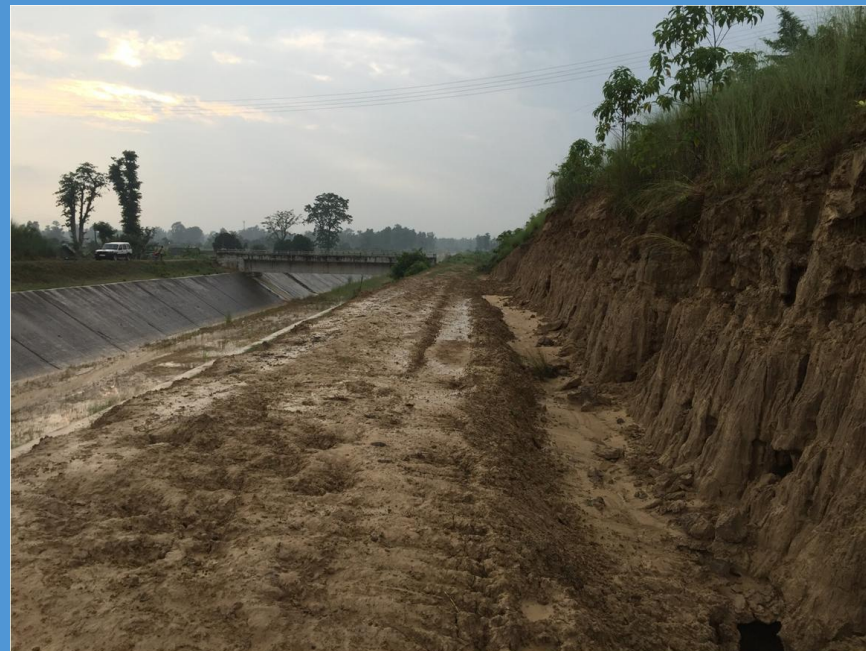
३ घुलनशिल माटोको समस्या समाधान

निर्माण भएको करिब ३ वर्ष पछि

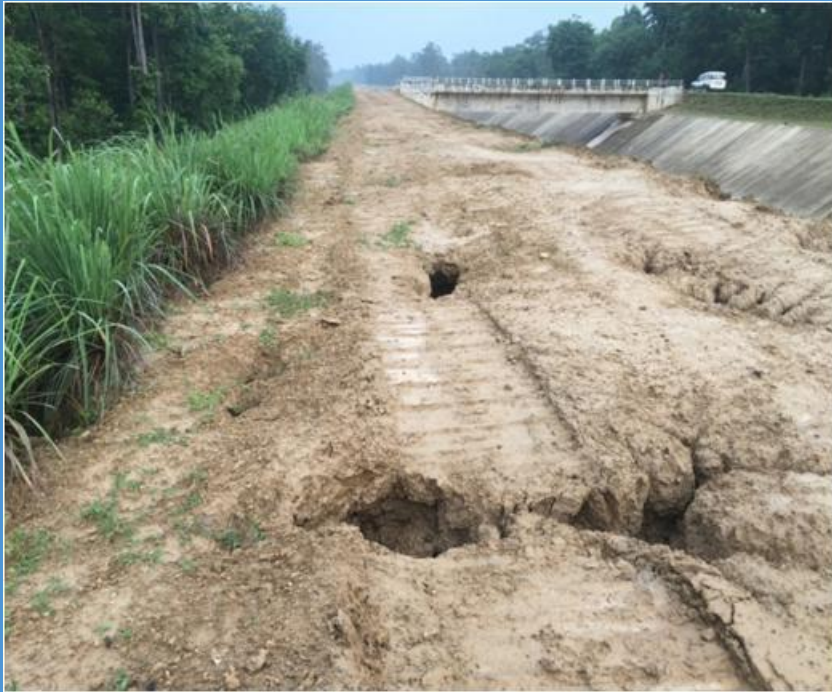
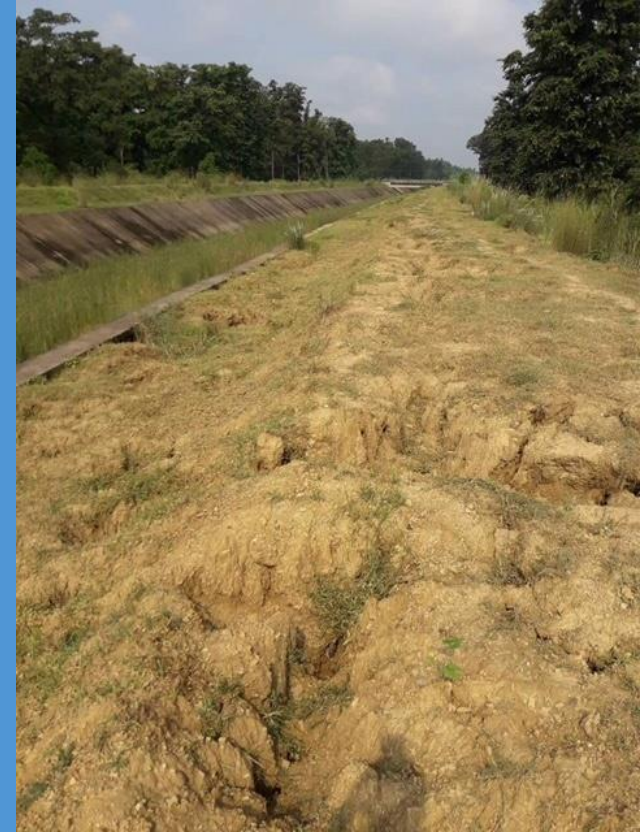
निर्माण भएको करिब ३ वर्ष पछि

Deep cutting area- Reach 21+175 TO 22+740 (Balapur village area)

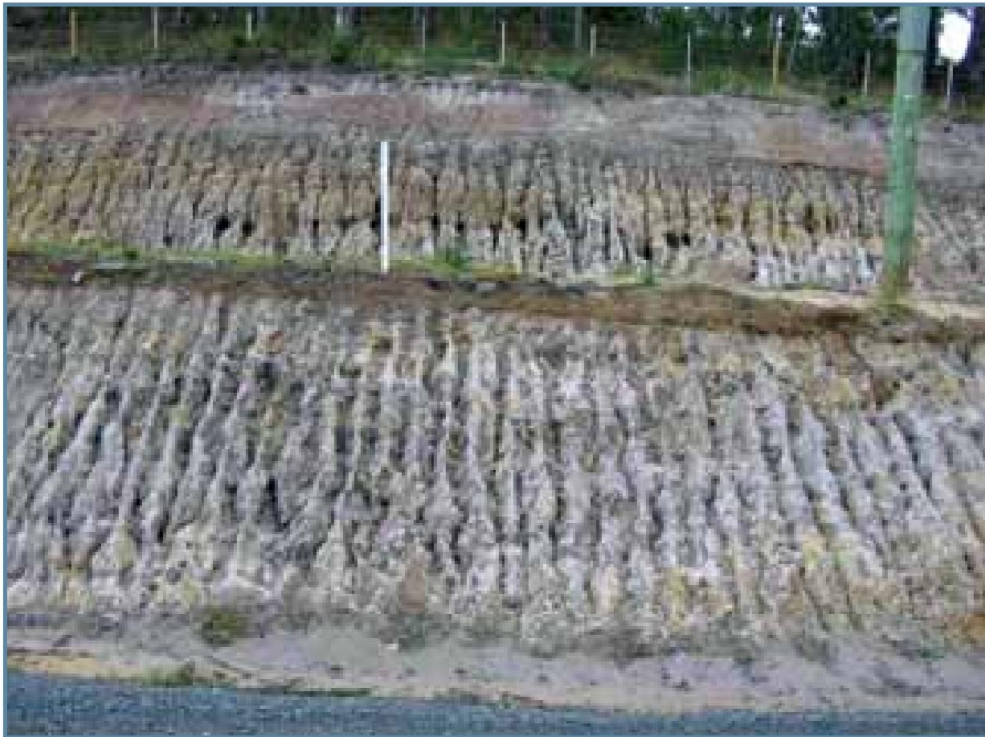
topsoil removal, surface water has dissolved through the soil surface. Soils derived from Triassic

Figure 28. Rill and tunnel erosion caused by excavation of sodic soils for road construction. Dunalley.

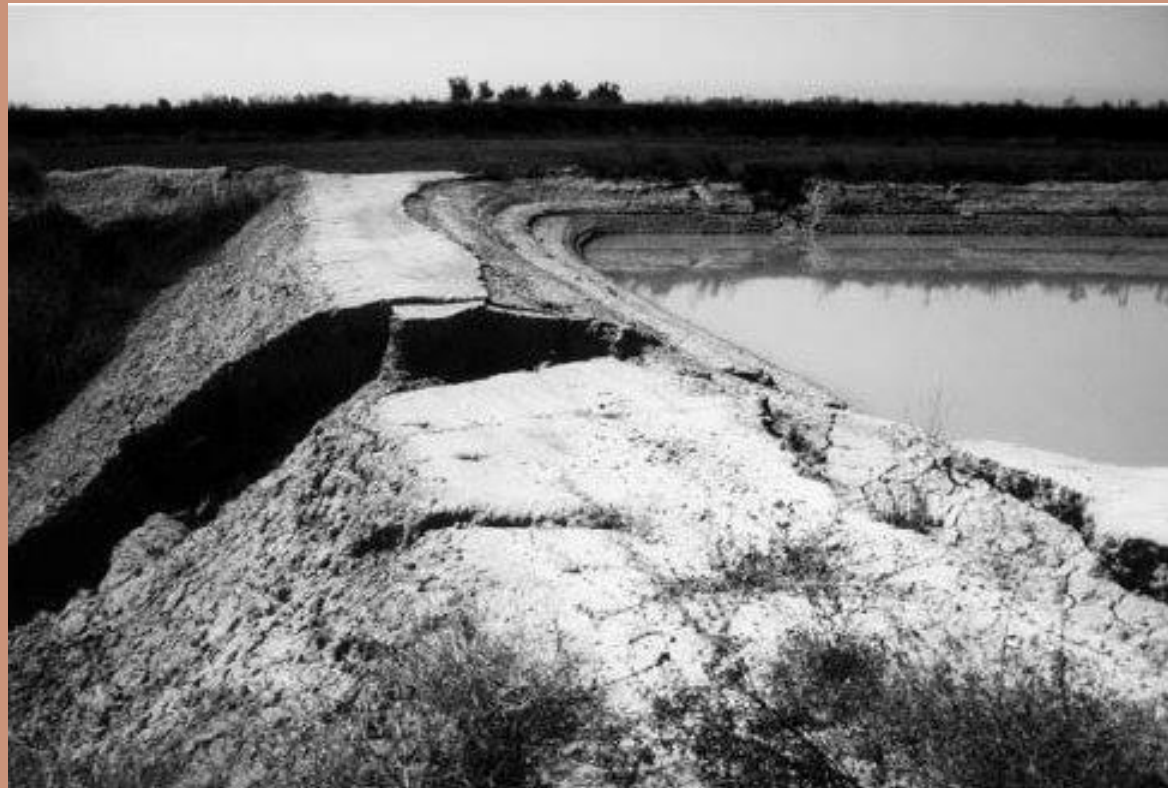
**Failed Canal Lining and Sink Hole on the Embankment
in Moghan Irrigation Project, Iran (Photo : Rahimi et
al. 2011)**

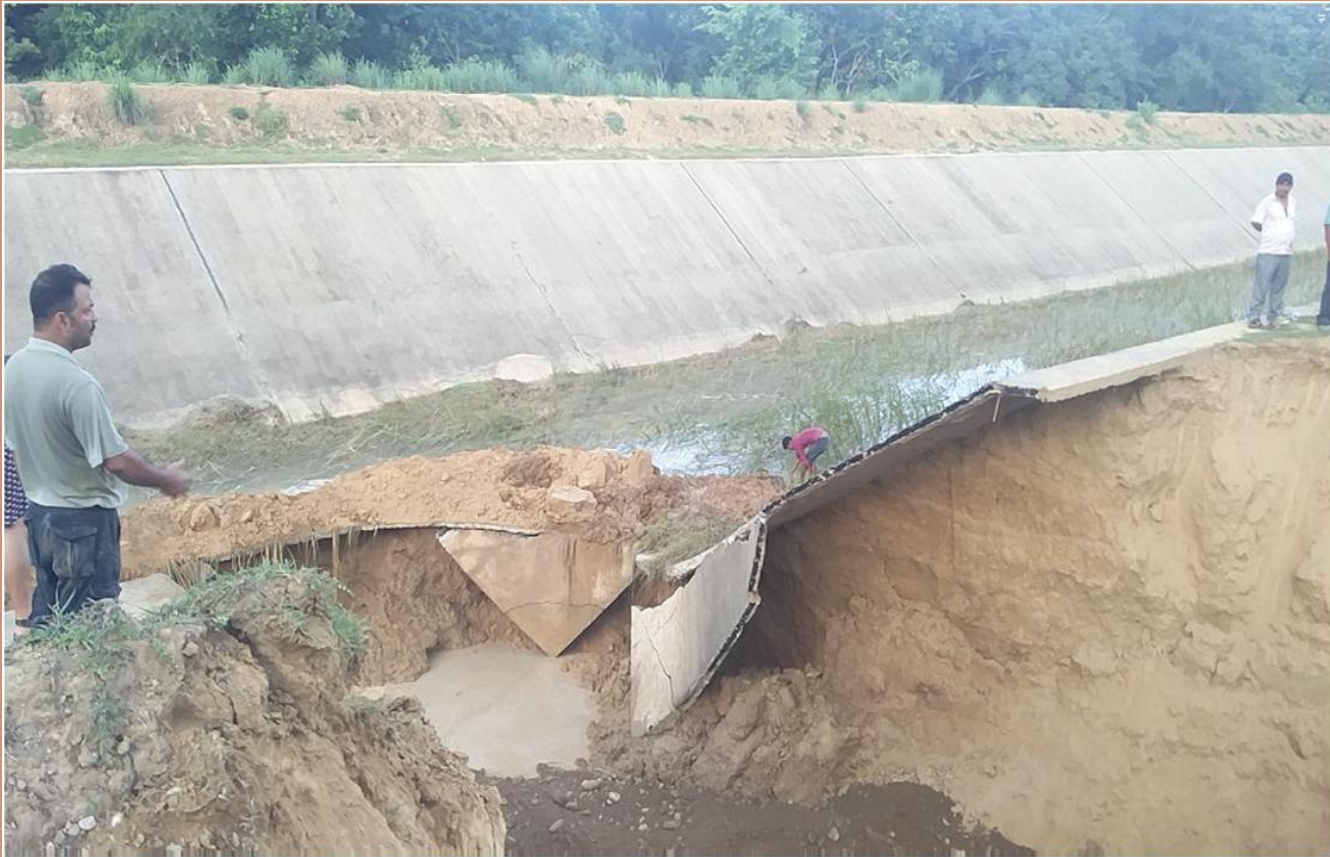
San Juan reservoir failure (2001) in Huesca, Spain

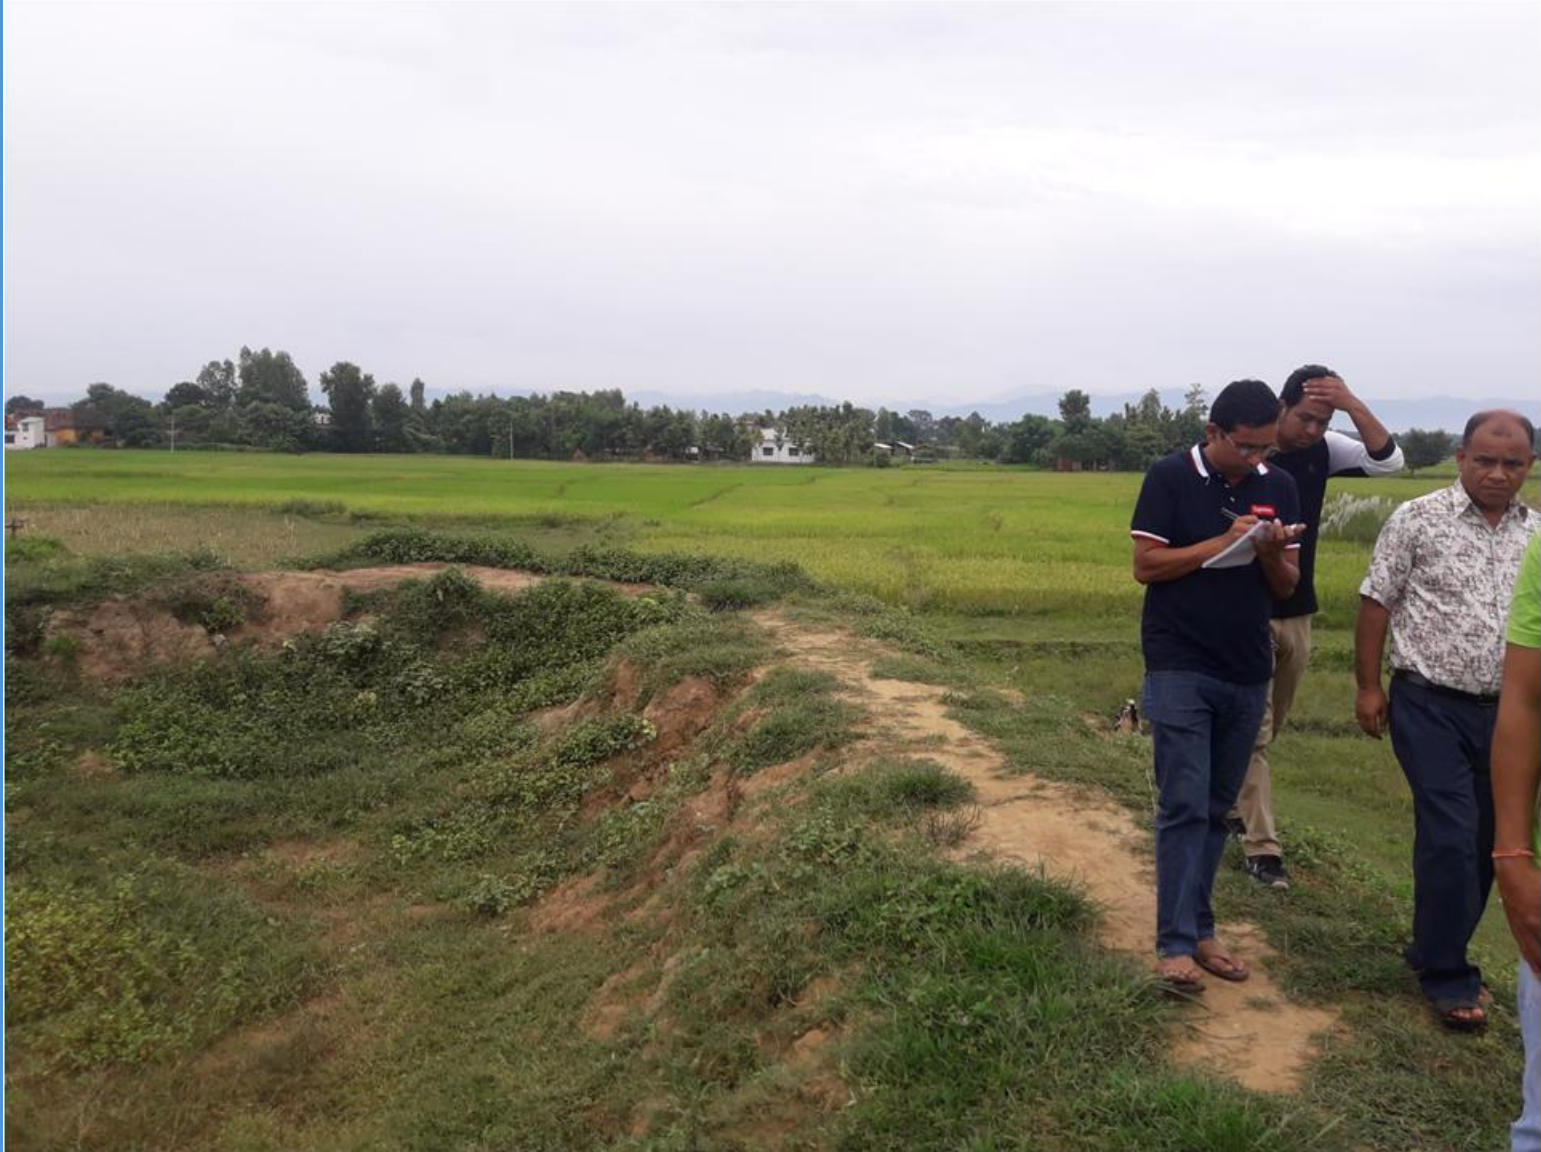
जग्गा विवादका कारण अधुरो नहर

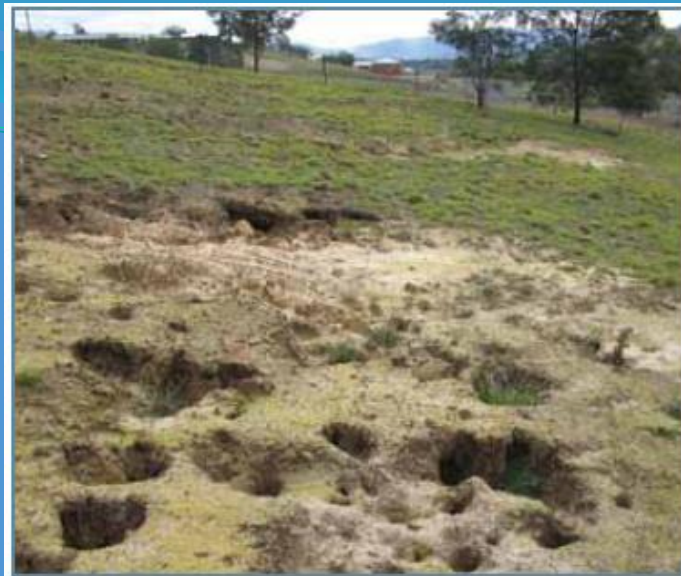
Figure 16. Initiation of tunnel erosion caused by scalping or removing topsoil. Note that even a very thin layer of topsoil was able to prevent widespread tunnel erosion
